Road Safety Audit Rochester, NH

Intersection: Old Dover Road and Tebbetts Road

Presented by
VHB

September 12, 2019

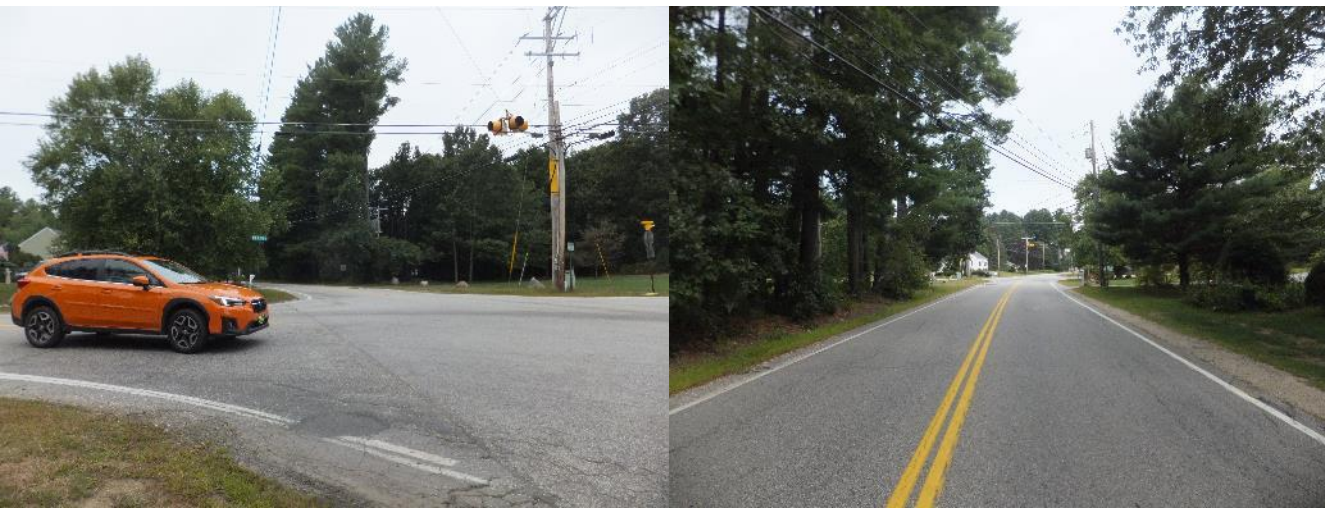
- Sight obstructions in the NW and NE corners
 - Trees, utility poles (redundant), brush, landscaping
 - Trees create shadowing effect as well (could lead to issues with eyes adjusting coming out of the dark and into the light)
- Difficult to see minor roads from SB Old Dover Rd
 - Overhead beacon is only indication of the location
 - Tree canopy contributes and sight obstructions in NW and NE corners
 - No advance warning on SB approach

- Trim trees and vegetation in northeast and northwest corners to raise the tree canopy within the right-of-way
 - Same outside the right-of-way...work with property owners
 - History of cooperation from property owners
- Install advance intersection warning sign on southbound approach
 - Consider relocating northbound advance intersection warning sign
 - Add street name plaques to both northbound and southbound advance intersection warning signs
- Locate street name signs at the intersection where they are more visible from southbound Old Dover Rd

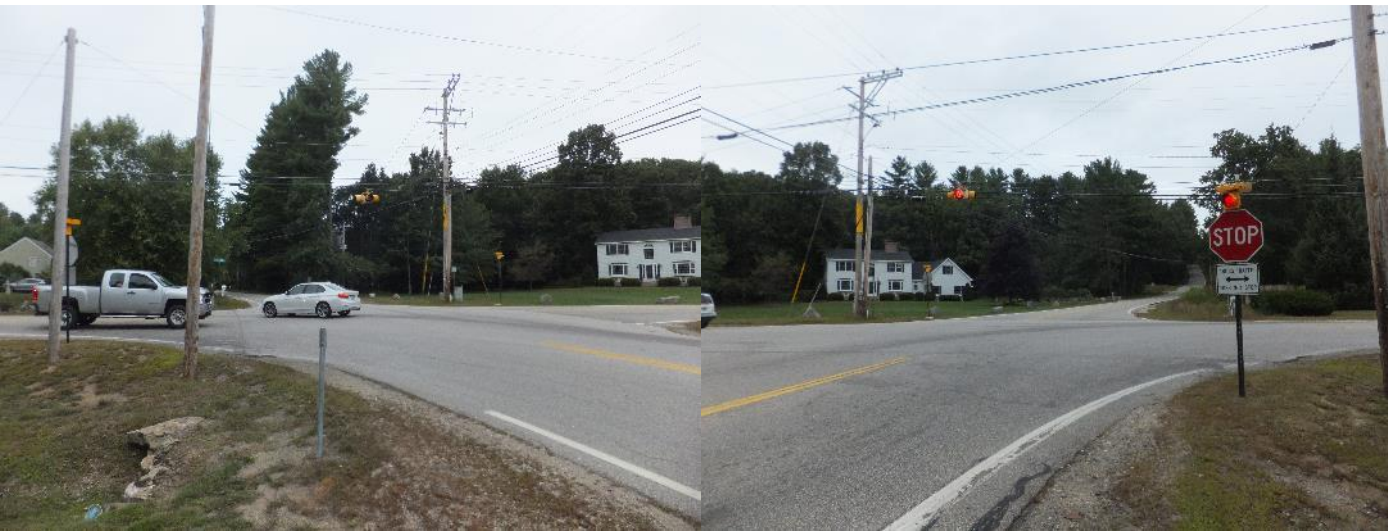
- Fixed objects on all 4 corners near roadway
 - Ditch on SE corner and dip in the pavement
- Minor issues on Tebbetts Rd
 - Faded stop bar on EB approach
 - Alignment of flashing beacon on STOP sign on EB approach
 - Flashing pattern may be a concern (rapid flash)
 - 'Cross traffic does not stop' signs are white (yellow would be more appropriate and may help with conspicuity)

- Good placement of stop bars but refresh eastbound stop bar
- Realign flashing beacon on STOP sign on eastbound approach
 - Look into flashing pattern and change as needed
- Replace 'Cross traffic does not stop' signs with yellow signs to help with conspicuity of the intersection
 - Look into research for placement of supplemental plaque under STOP sign (abutting or space in between)

- Remove redundant utility poles as possible
- Pole for flashing beacon is redundant in southwest corner
 - Is it possible to tie to the utility pole (or not based on utility policy)
- Delineate utility poles with object markers

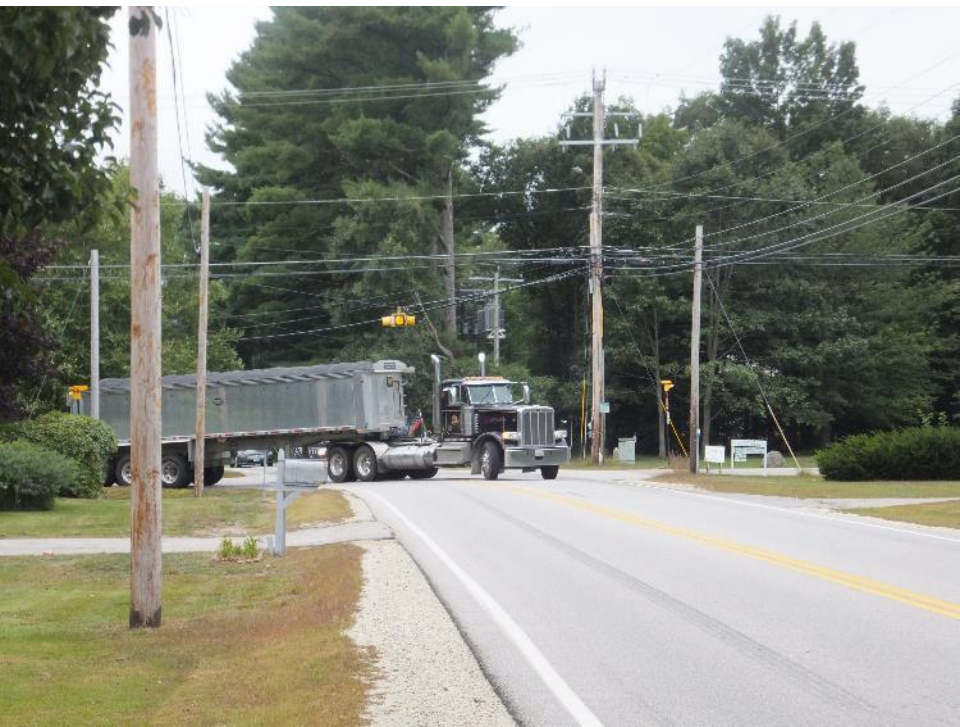
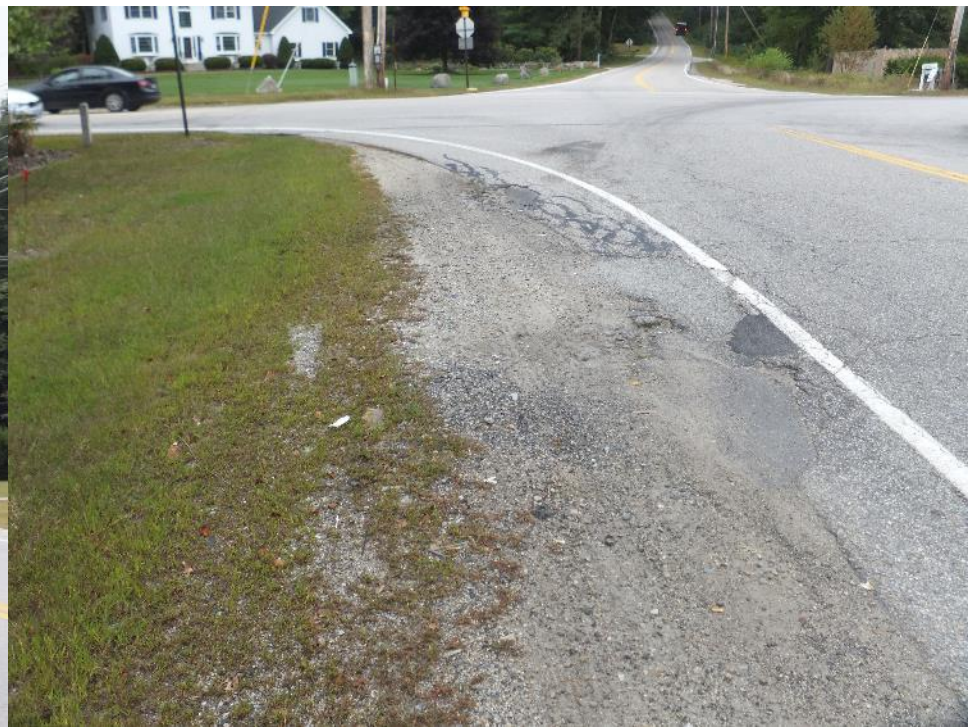
- Large trucks
 - Trucks using this route as cut-through to NH 108 and NH 125
 - Contributing to rutting along the edge of pavement
 - Wide turns create off-tracking into opposing lanes and using the shoulder of the road

1. Discussion of large trucks
 1. May not be contributing to historical crashes
 2. What does prohibition do to other routes (shift issue)
 3. Would require enforcement which would detract from other priorities
 4. Wide turns create off-tracking into opposing lanes and using the shoulder of the road
 5. Would a roundabout or 4-way STOP deter or discourage trucks from using the route (or would the roundabout provide a better turning opportunity)

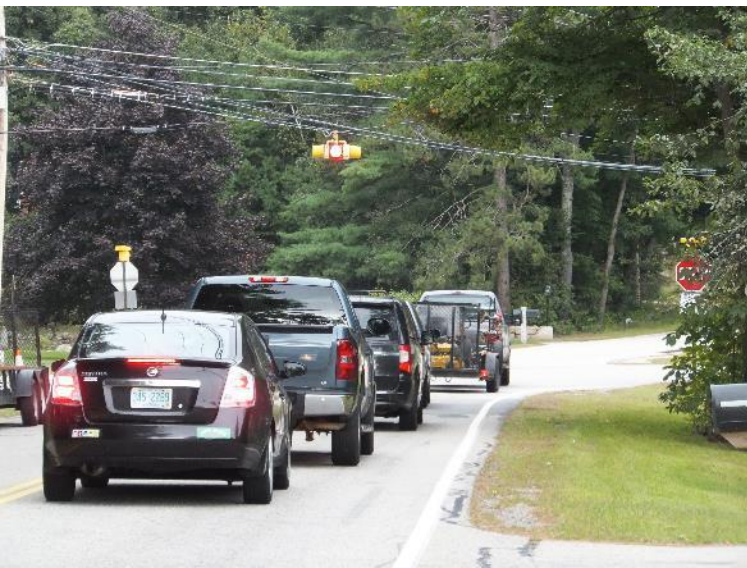
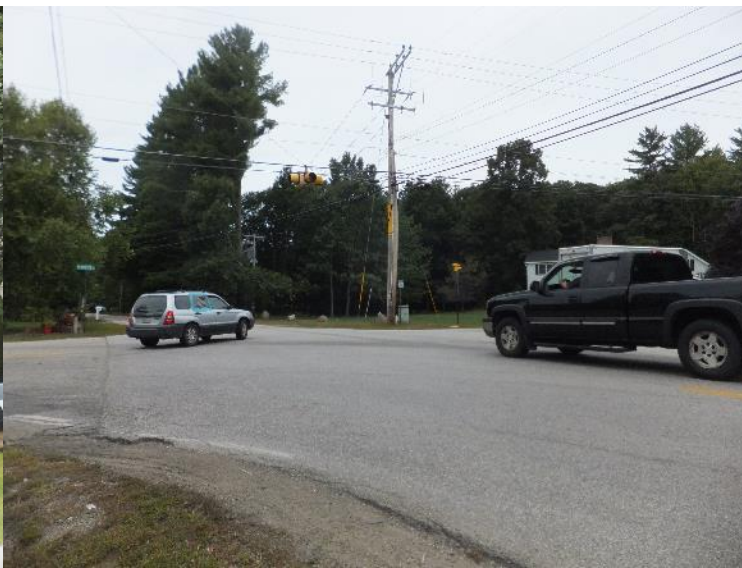
- Drivers on Old Dover and Tebbetts may perceive as 4-way stop
 - Some drivers on Tebbetts go when they should stop
 - Some drivers on Old Dover stop when they should go
- Drivers on Tebbetts may be misjudging gaps
- Queuing on Tebbetts could lead to driver impatience or aggressive maneuvers
 - Consider shiftwork from Safran (does this correlate with 3pm crash pattern?)

- Consider converting to 4-way stop-controlled
 - Could create issues for large trucks turning around stopped vehicles
 - Consider interim supplemental signs/warnings (maybe message boards) to alert drivers to change in traffic control; potential for flashing LED border (temporary)
 - Potential to add STOP AHEAD pavement markings and temporary transverse rumble strips
 - Request turning movement counts and run simulation to check change in delay on Old Dover Rd and Tebbetts Rd
- Intersection Conflict Warning System (ICWS) was discussed but probably not a prime candidate for this location given the opportunity for physical (geometric) and operational changes to the intersection

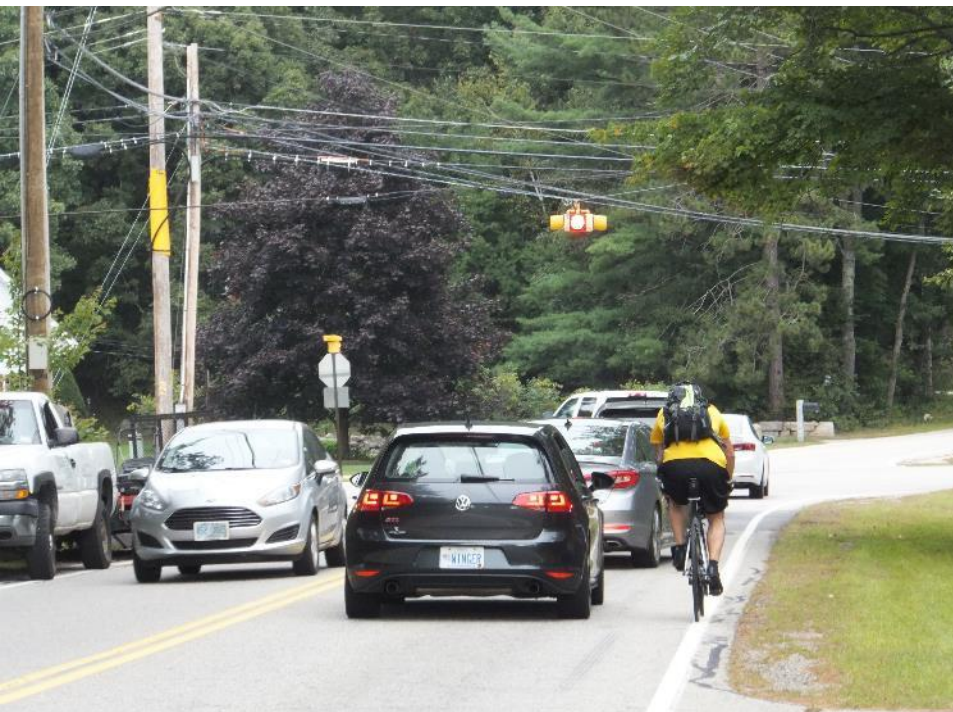
- Sun glare is an issue at certain times of the year
- Pedestrians and joggers using the shoulder of the road, which is relatively narrow
- Bicyclists are present as well
