City of Rochester Dept of Public Works

Memo

To: Planning Board
From: Peter Nourse, City Engineer
CC: Michael Behrendt, Chief Planner
Date: 26 March, 2012
Re: Chamberlain Investment Subdivision Suitability for Acceptance

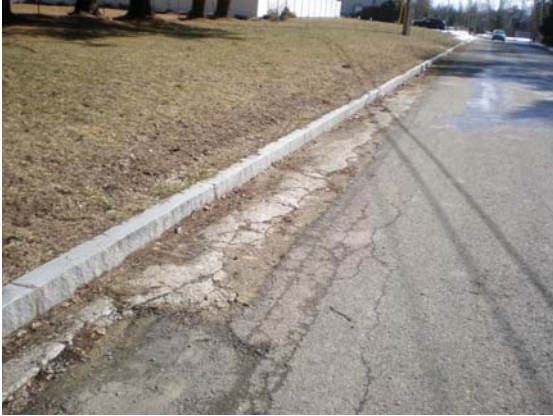
Some curbing has rotated due to inadequate concrete backing. The condition of the concrete backing is poor. In addition, much of the mortar between curbing units has fallen out.

Fig 1. Concrete curb backing in poor condition and rotation of curbing. Cracks are a sign of inadequate compaction of sub materials.

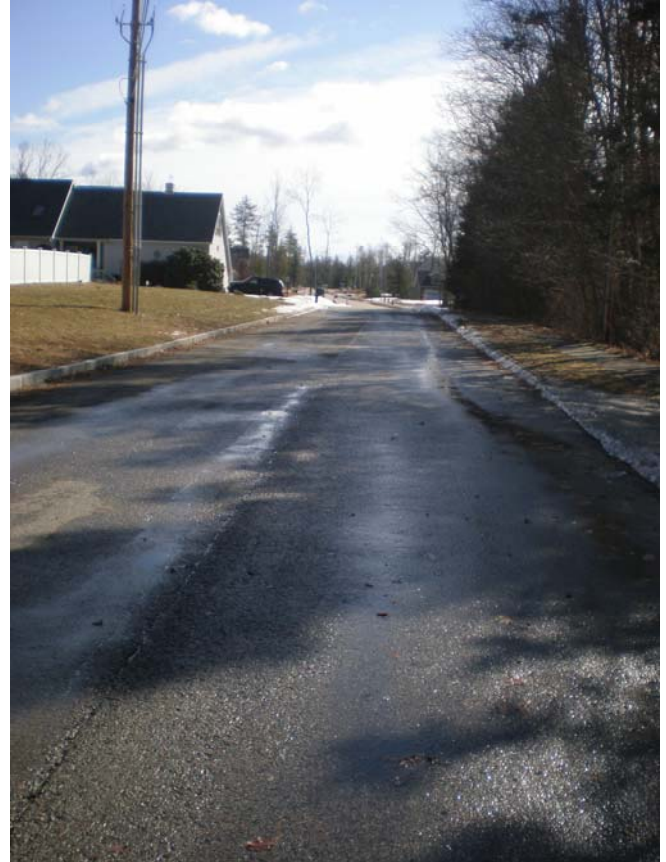
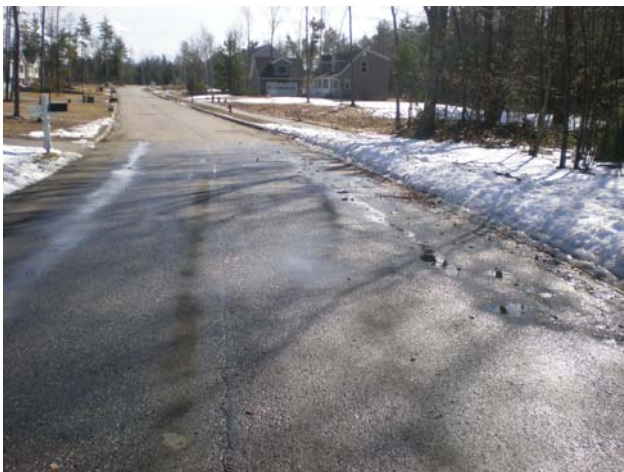
Anderson Lane exhibits settling along much of its length in the form of rutting wheel channels. They are most pronounced following a rain. It also exhibits an 800 foot long longitudinal crack. The crack is wide and has expanded in width over the winter. The crack may be due to inadequate tacking of asphalt course passes.

Figs 2-3. Longitudinal crack from Franklin St. in approximately 800 feet to No. 34. The crack indicates inadequate tacking of coats. Crack will at least require saw cutting out. Layering wear course over this will result in reflective cracking in near future. Note the rutting of the road in the wheel tracks. This indicates inadequate base materials and/or compaction thereof.

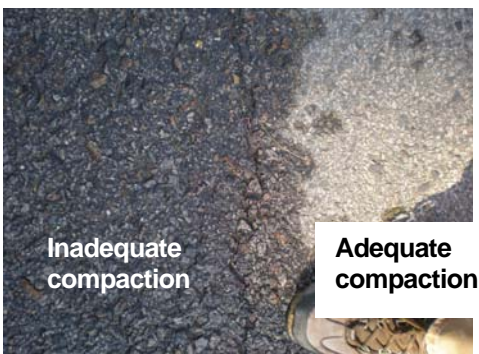
Fig 4. The longitudinal crack. Note that on one side the grouping of aggregate is close whereas on the other side it is loosely spaced indicating inadequate compaction and rolling technique.

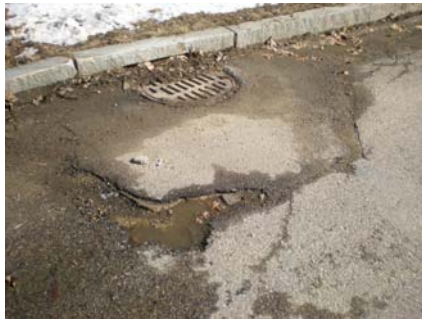
There are areas of settlement at several structures in the streets. This may be a result of inadequate local compaction around structures and/or inadequate materials.

Fig 5. Pavement problems at interfaces with structures.

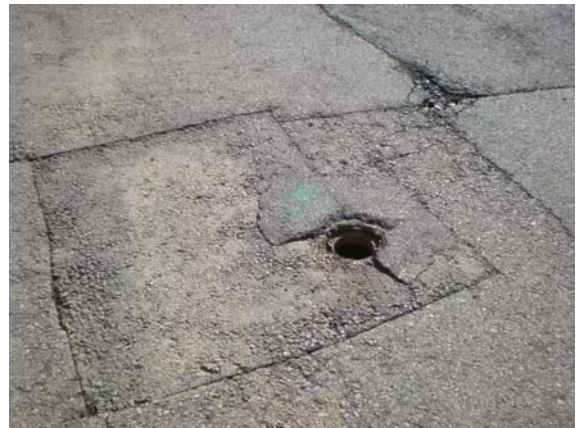
Fig 6. Subsidence near structures indicates inadequate materials and/or compaction thereof. Note missing cover.

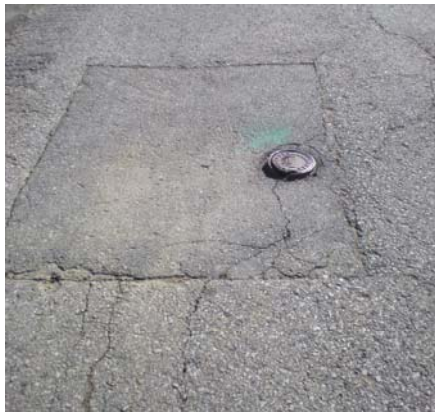
Fig 7. Subsidence near structures indicates inadequate materials and/or compaction thereof. Note missing cover.

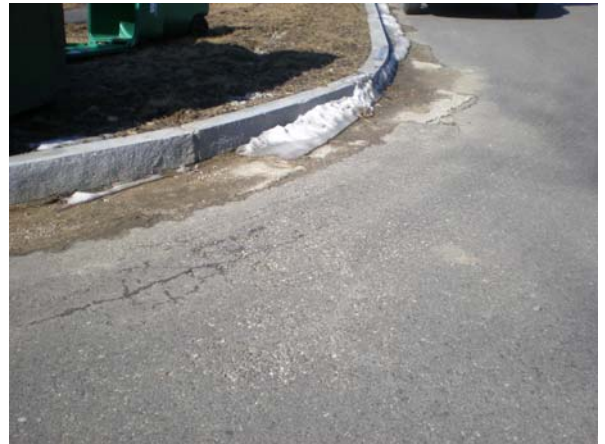
Fig 8. Low shoulder and inadequate compaction results in ponding water.

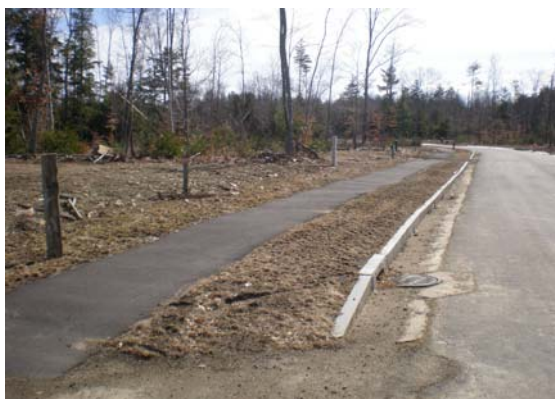
Sidewalks: There exist approximately 1550 feet of asphalt sidewalks on Collins and Givens Circles. They are wavy in profile and the cross slopes are extreme. They are in no way ADA compliant. The sub base material is suspect and/or the degree of workmanship.

Fig 9. Sidewalk longitudinal and cross slopes are wavy and not ADA compliant. Additional pavement will not solve this problem. Sub-base material is in question.

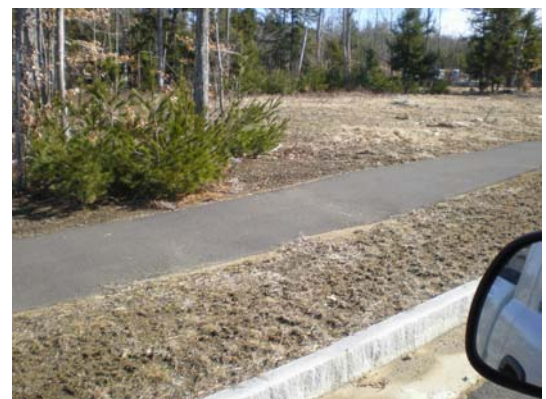
Fig 10. Sidewalk cross-slopes way exceed 2% per code.

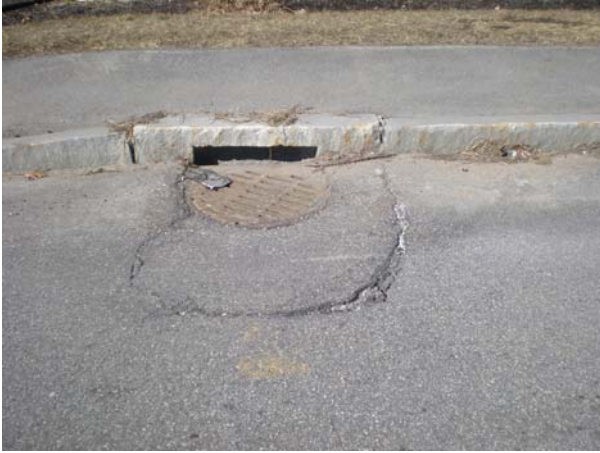
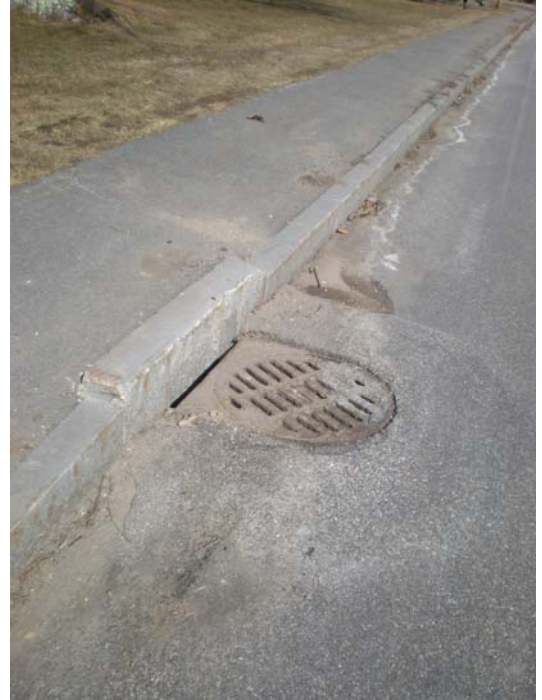
Figs 11-12. Franklin St. drainage structures. Negative drainage due to heaving of structures. Sub-base materials and/or degree of compaction thereof suspect.

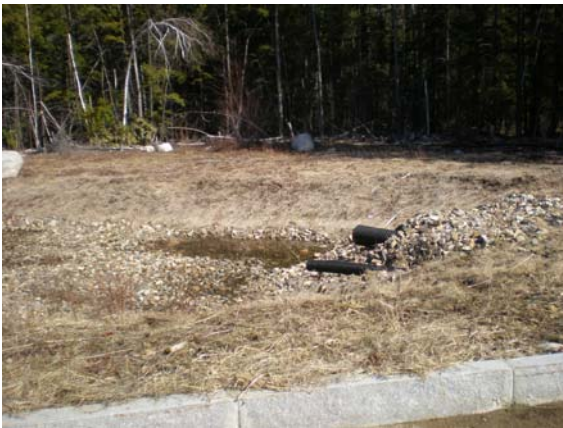
Fig 13. Drainage ponds remain unfinished and apparently modified in configuration from drawings.
