REPORT

CITY OF
Rochester
New Hampshire

Year One I/I Investigations – Phase 2 –
CCTV Inspections

Re: **Year 1 Phase 2 I/I Investigations CCTV Video Review**

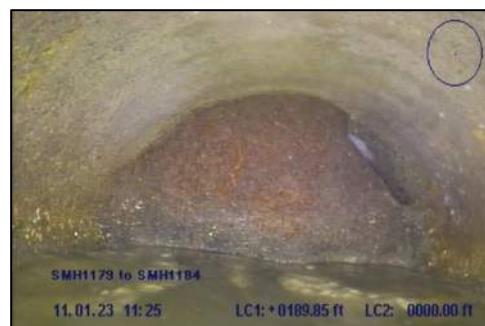
Photo 1: Root Ball in Sewer Segment SP00936 on Eastern Ave at STA 1+90

Note: The roots shown in Photo 1 were removed from the sewer line after the initial inspection. BMC cut the roots on 4/5/2023.

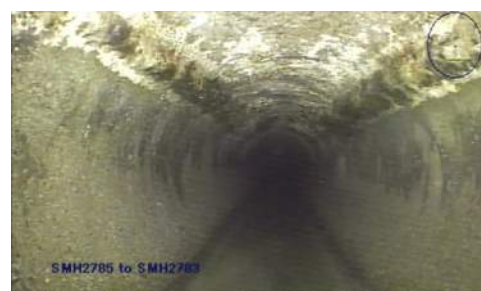
Photo 2: Grease in Sewer Segment SP02126 on River Street

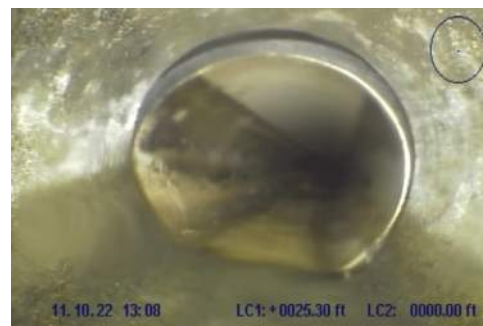
There are four, sewer segments that were observed to include a decrease in diameter within the pipe, which creates a potential for a hydraulic restriction. While this is not necessarily a problem, these may be “choke points” that can increase the potential for surcharging, overflows, and buildup of debris. Six pipe repairs were observed in sewer segments SP00686 and SP00692 on Portland Street, SP02225 on Wakefield Street, SP00585 on Walnut Street, and SP00925 on Highland Street. The first spot repair found on Portland Street is in the 8-inch AC sewer pipe SP00686 made with a 6-inch PVC section of pipe (Photo 3). The spot repair found on Wakefield Street is in the 10-inch VCP sewer pipe SP02225 made with an 8-inch PVC section of pipe. It is recommended these sewer segments be reviewed for a history of backups and surcharging to determine if these potential hydraulic restrictions are affecting the pipe capacity. It should be noted that the main section of pipe in the sewer pipe SP00686 is 8-inch AC and there is also 6-inch AC in the pipe.

Photo 3: Pipe Repair in Sewer Segment on Portland Street SP00686

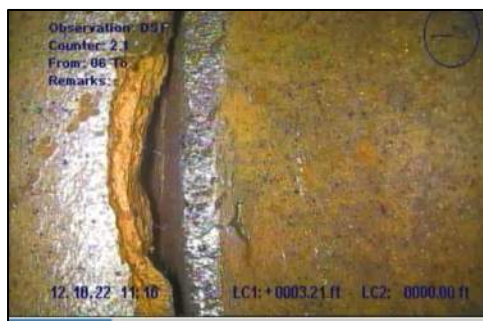
In Asset ID SP02225 (10-inch VCP), there is a broken pipe at STA 0+03 (observed downstream of manhole SMH1392).

Photo 4: Broken pipe at STA 0+03

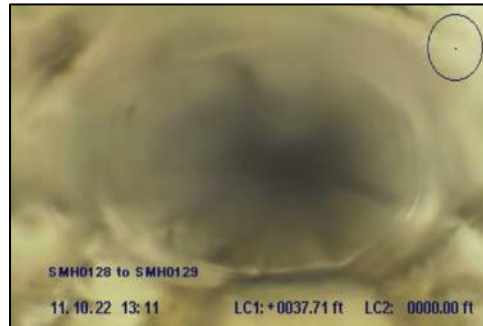
In Asset ID SP00686 (8-inch PVC), there is a deformed flexible elliptical segment of PVC pipe at STA 0+38 (observed upstream of manhole SMH0128).

Photo 5: Deformed flexible elliptical pipe at STA 0+38

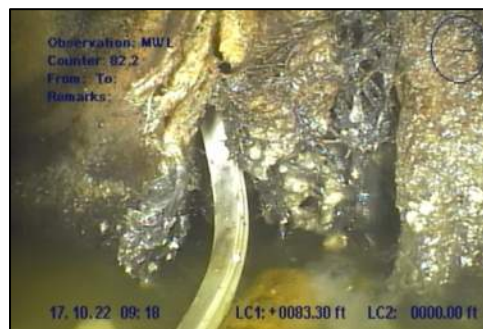
In the Asset ID SP00685 (6-inch AC), there is a piece of plastic, a hole, and fine roots in a joint at STA 0+83 (observed upstream of manhole SMH0129).

Photo 6: Plastic in joint at STA 0+83

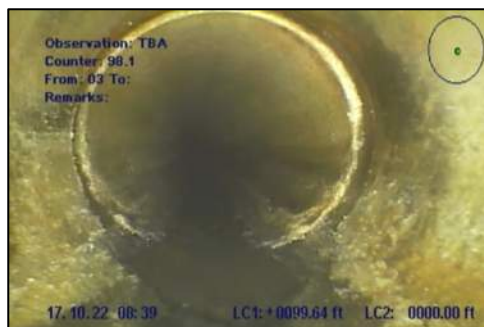
In Asset ID SP00685 (6-inch AC), there is a missing wall in the pipe at STA 1+00 and hole at STA 1+34 (observed upstream of manhole SMH0129).

Photo 7: Surface damage missing wall at STA 1+00

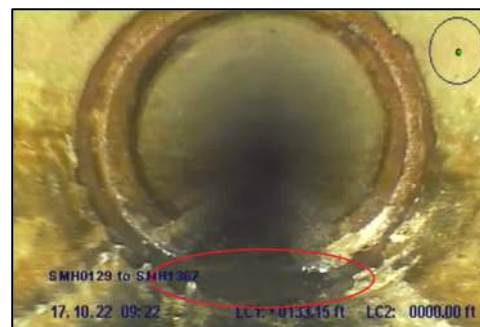
Photo 8: Hole at STA 1+34

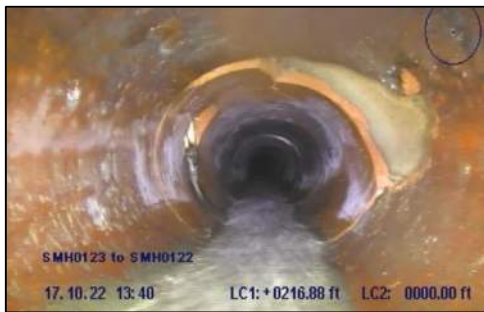
In Asset ID SP00692 (10-inch VCP), there are holes at STA 1+48 and STA 2+18 (observed downstream of manhole SMH0123). A repair patch behind the hole at STA 2+18 was also discovered, so there is other material behind the broken pipe.

Photo 9: Hole at STA 2+18

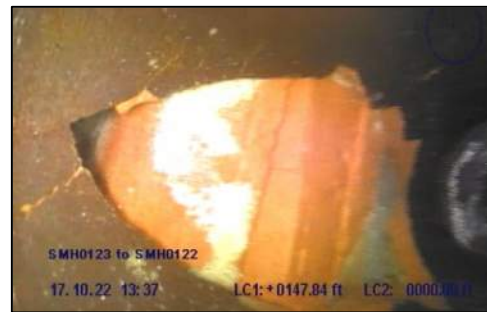
Photo 10: Hole at STA 1+48

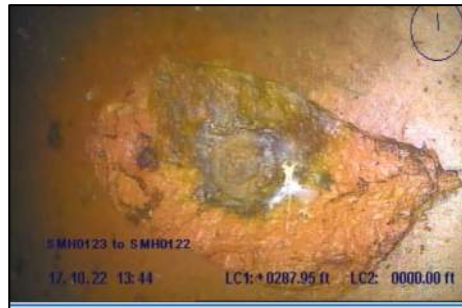
In Asset ID SP00692 (10-inch VCP), there is a missing wall at STA 2+88 (observed downstream of manhole SMH0123).

Photo 11: Surface damage missing wall at STA 2+88

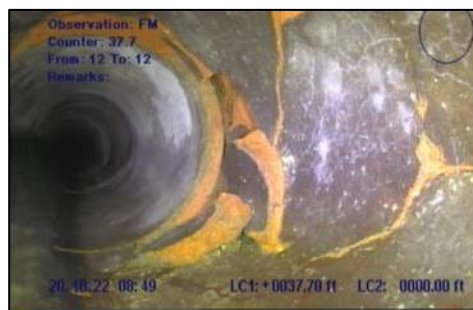
In Asset ID SP00693 (10-inch VCP), there are multiple fractures at STA 0+38 (observed upstream of manhole SMH0121).

Photo 12: Fracture multiple at STA 0+38

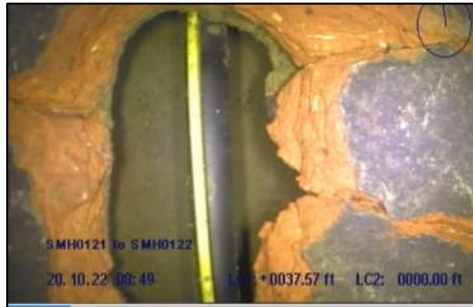
In Asset ID SP00693 (10-inch VCP), there is a hole at STA 0+38 (observed upstream of manhole SMH0121). A gas line exposed behind the hole.

Photo 13: Hole at STA 0+38

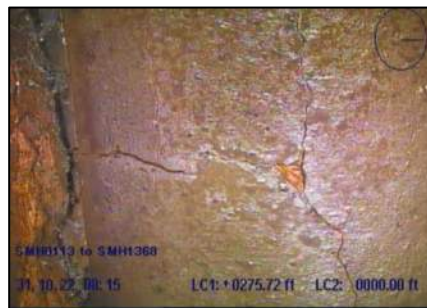
In Asset ID SP01114 (10-inch VCP), there are multiple fractures at STA 2+76 (observed upstream of manhole SMH0113).

Photo 14: Fracture multiple at STA 2+76

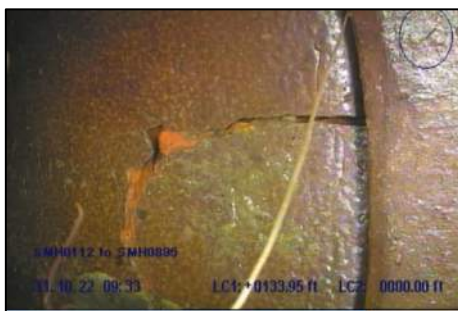
In Asset ID SP01116 (10-inch VCP), there are spiral fractures at STA 0+79 and STA 1+34 (observed downstream of manhole SMH0112).

Photo 15: Fracture spiral at STA 1+34

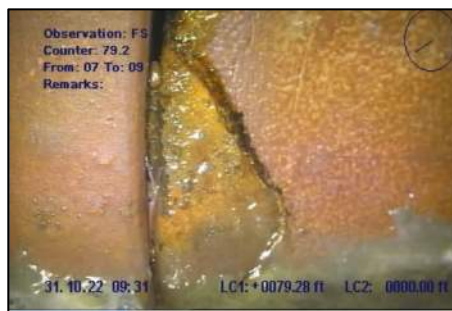
Photo 16: Fracture spiral at STA 0+79

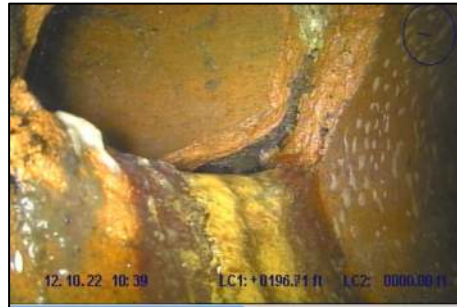
In Asset ID SP00315 (10-inch VCP), there is a hole with a visible void at STA 1+97 (observed downstream of manhole SMH0115).

Photo 17: Hole void visible at STA 1+97

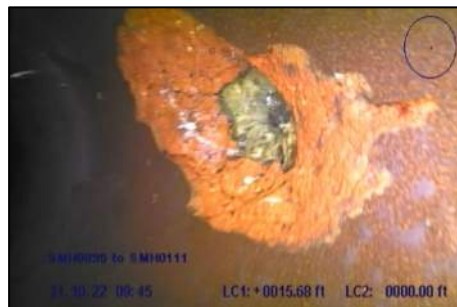
In Asset ID SP00317 (10-inch VCP), there is a hole at STA 0+16 (observed downstream of manhole SMH0895).

Photo 18: Hole at STA 0+16

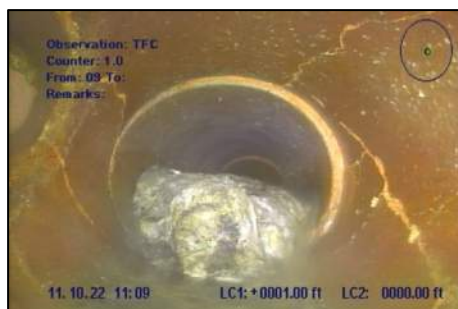
In Asset ID SP00687 (8-inch VCP), there are spiral fractures at STA 0+01 and STA 3+77 (observed upstream of manhole SMH0128).

Photo 19: Fracture spiral at STA 0+01

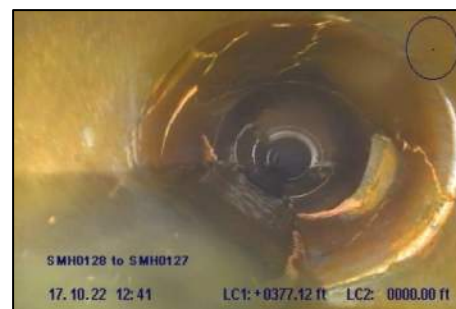
Photo 20: Fracture spiral at STA 3+77

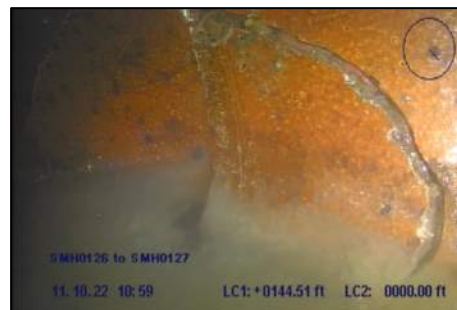
In Asset ID SP00688 (8-inch VCP), there is a spiral fracture at STA 1+45 (observed upstream of manhole SMH0126).

Photo 22: Fracture spiral at STA 1+45

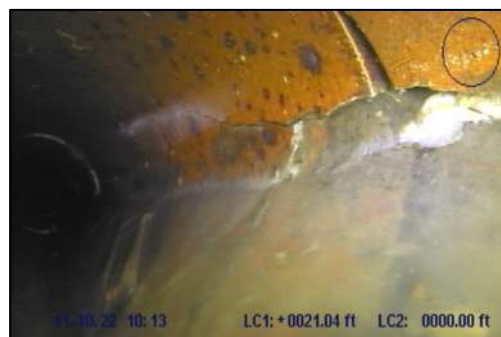
In Asset ID SP00689 (8-inch VCP), there is a hole at STA 0+21 (observed downstream of manhole SMH0126).

Photo 23: Hole at STA 0+21

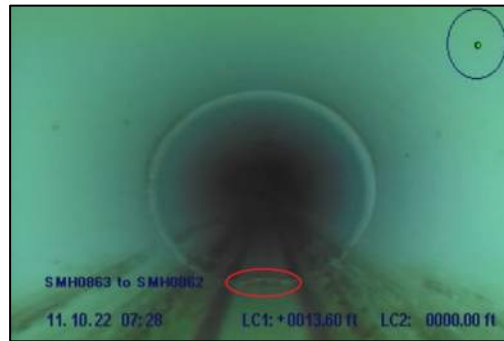
In Asset ID SP01331 (8-inch PVC), there is a hole at STA 0+14 (observed downstream of manhole SMH0863).

Photo 24: Hole at STA 0+14

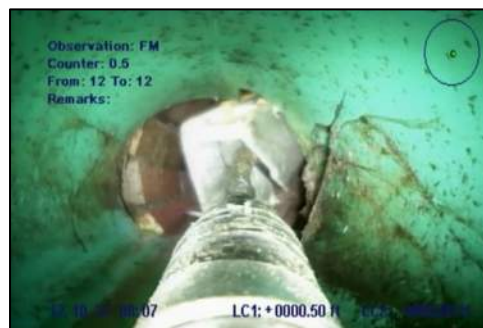
In Asset ID SP00170 (8-inch PVC), there are multiple fractures in the pipe at STA 0+01 (observed upstream of manhole SMH0351).

Photo 25: Fracture multiple at STA 0+01

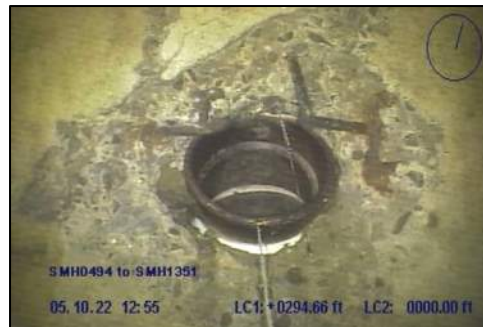
In Asset ID SP01172 (24-inch RCP), there is surface damage in the pipe at STA 2+95 (observed upstream of manhole SMH0494).

Photo 26: Surface damage at STA 2+95

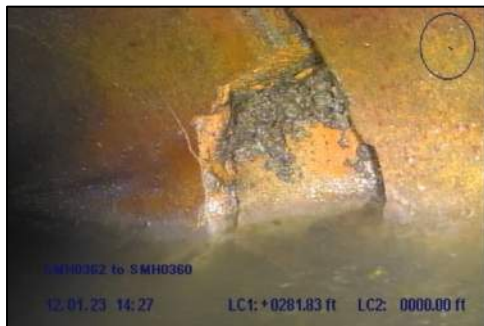
In Asset ID SP00585 (8-inch VCP), there are holes at STA 2+82 and at STA 3+16 (observed upstream of manhole SMH0360).

Photo 27: Hole at STA 2+82

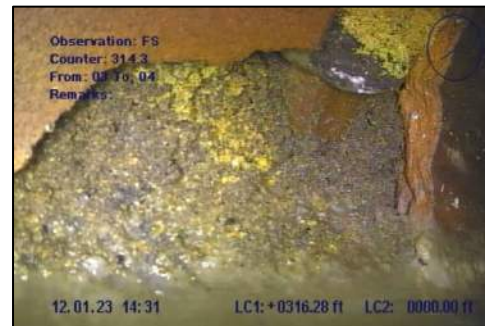
Photo 28: Hole soil visible at STA 3+16

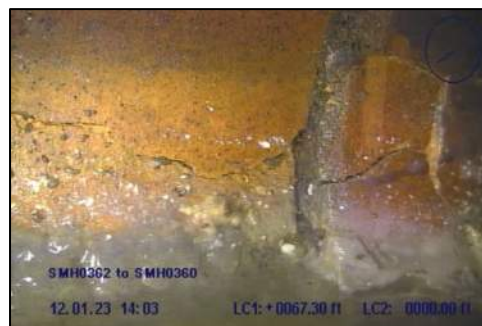
In Asset ID SP00585 (8-inch VCP), there are multiple fractures at STA 0+67, 1+10, STA 1+85, STA 2+57, and STA 2+90 (observed upstream of manhole SMH0360). There were also spiral fractures at STA 2+64 and STA 3+06.

Photo 29: Fracture multiple at STA 0+67

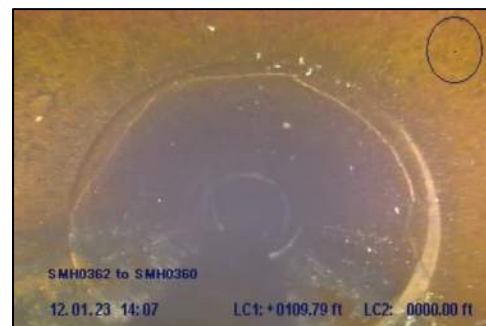
Photo 30: Fracture multiple at STA 1+10

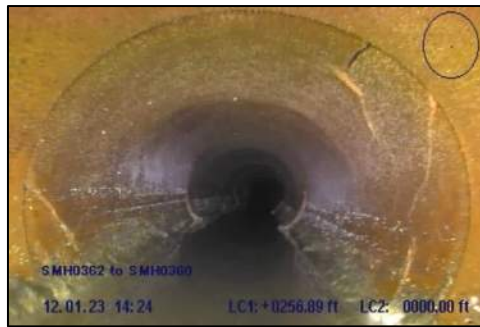
Photo 31: Fracture multiple at STA 2+57

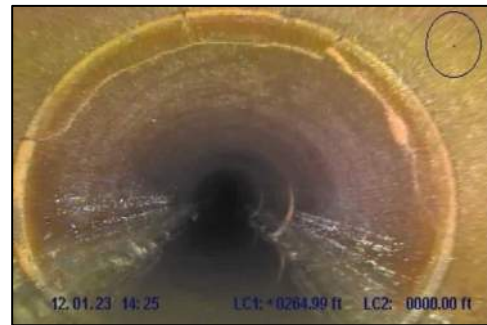
Photo 32: Fracture spiral at STA 2+64

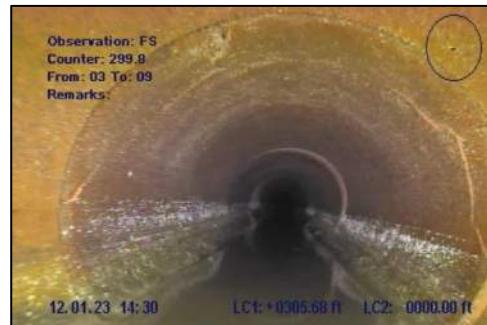
Photo 34: Fracture spiral at STA 3+06

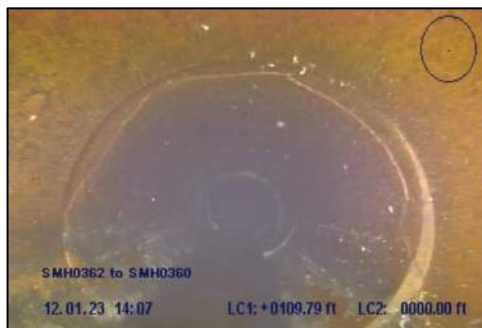
Photo 35: Fracture multiple at STA 1+10

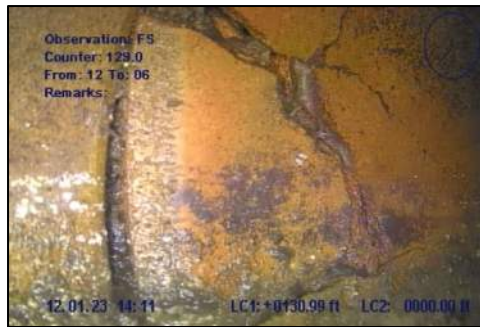
In Asset ID SP00585 (8-inch VCP), there are broken pipe sections at STA 1+31 and 1+92 (observed upstream of manhole SMH0360).

Photo 37: Broken pipe at STA 1+31

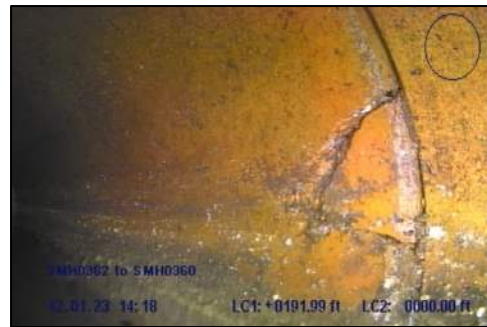
Photo 38: Broken pipe at STA 1+92

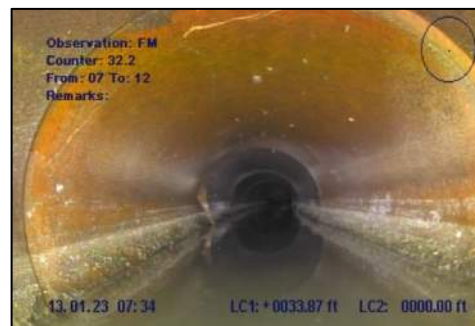
In Asset ID SP01910 (8-inch VCP), there are multiple fractures at STA 0+34 (observed downstream of manhole SMH0360).

Photo 39: Fracture multiple at STA 0+34

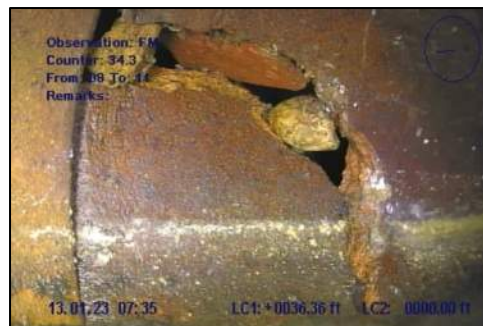
In Asset ID SP01910 (8-inch VCP), there is a hole with a void visible at STA 0+36 (observed downstream of manhole SMH0360).

Photo 40: Hole void visible at STA 0+36

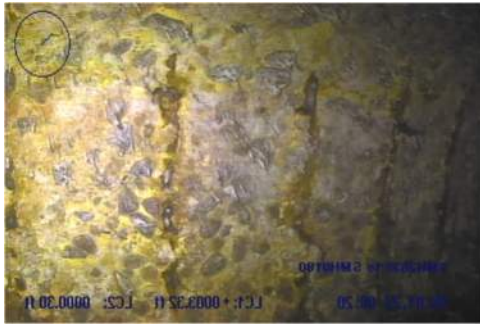
The City had a previous collapse on Highland Street on sewer segment SP00925, at the pipe connection of SMH0180. A PVC repair was installed from STA 0+00 to 0+27. This collapse most likely occurred as a result of H_2S corrosion from the force main, as explained above.

In Asset ID SP00925 (18-inch RCP), there is an area where reinforcement is visible at STA 0+03 and a missing wall at STA 1+31 and STA 1+48 (observed upstream of manhole SMH2638).

Photo 41: Surface damage reinforcement visible at STA 0+03

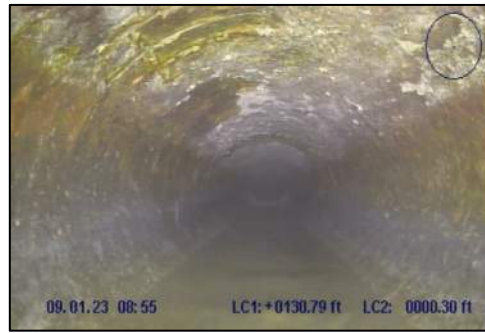
Photo 42: Surface damage missing wall at STA 1+31

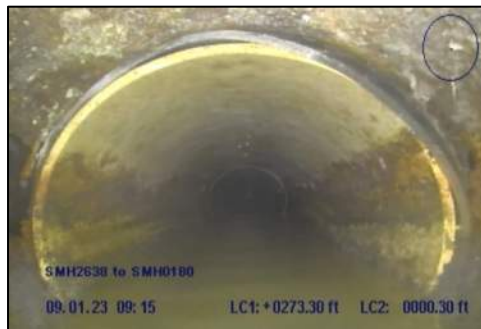
In Asset ID SP00925 (18-inch RCP), there is an offset joint at STA 2+75 from what appears to be a PVC repair (observed upstream of manhole SMH2638).

Photo 43: Joint connection lining defect at STA 2+75

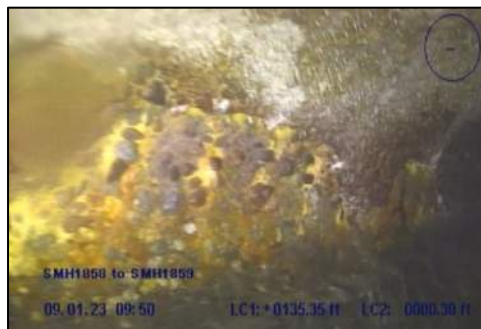
In Asset ID SP01947 (18-inch RCP), there is a missing wall at STA 1+35 (observed downstream of manhole SMH2638).

Photo 44: Surface damage missing wall at STA 1+35

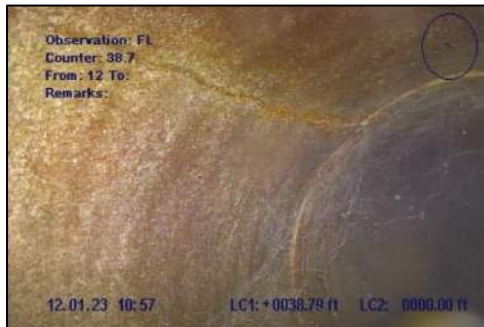
In Asset ID SP01267 (12-inch VCP), there is a longitudinal fracture at STA 0+39 and multiple fractures at STA 1+15 (observed upstream of manhole SMH0051). This fracture spans most of the pipe length at 0+06, from 0+09 to 0+20, from 0+32 to 0+65, from 0+72 to 0+75, from 1+15 to 1+22, and from

Photo 45: Fracture longitudinal at STA 0+39

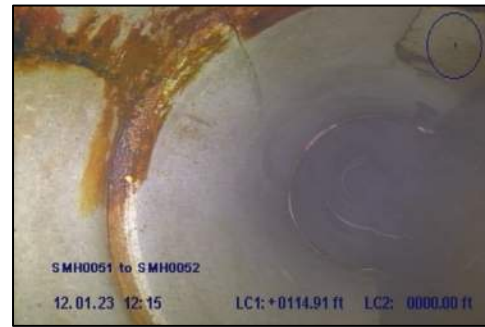
Photo 46: Fracture multiple at STA 1+15

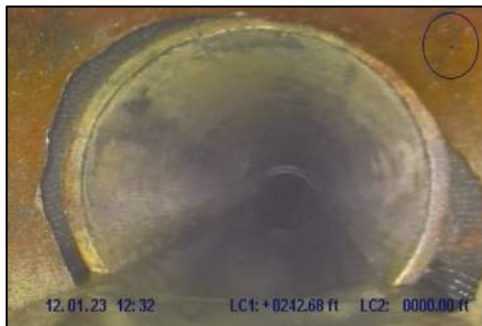
2+71 to 2+78, a total of 62 LF. At STA 2+44 and STA 2+50, there is an unknown material under the broken pipe. At STA 2+53 and STA 2+94, there is a broken pipe.

Photo 47: Unknown material under broken pipe at STA 2+44

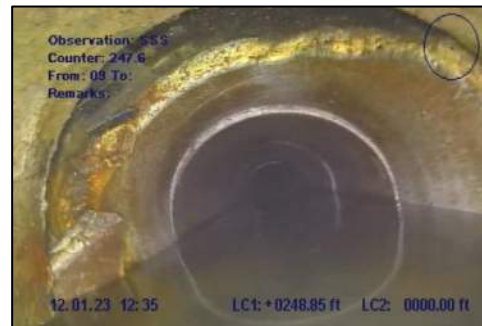
Photo 48: Unknown material under broken pipe at STA 2+50

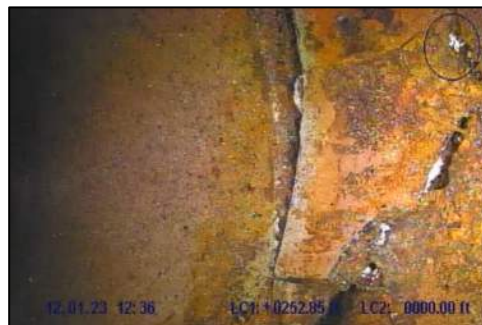
Photo 49: Broken pipe at STA 2+53

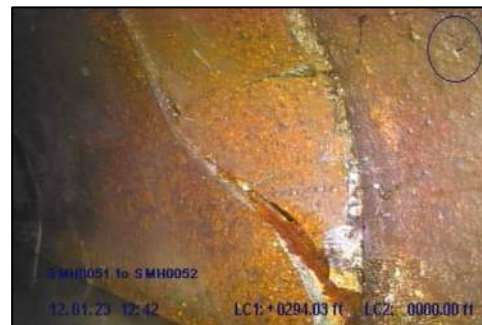
Photo 50: Broken pipe at STA 2+94

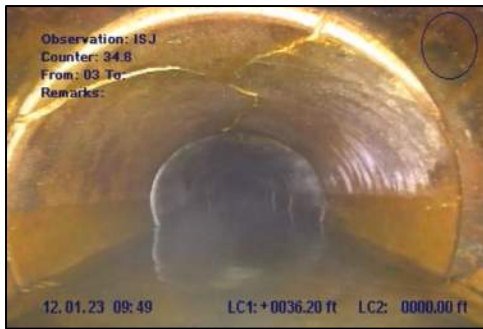
In Asset ID SP01268 (12-inch VCP), there are multiple fractures at STA 0+37 (observed downstream of manhole SMH0051). At STA 1+56 there is a longitudinal fracture at the top of the pipe that spans most of the pipe, at 0+08, from 0+23 to 0+27, from 0+37 to 0+43, from 0+50 to 0+59, 0+69, 1+00, from 1+40 to 1+76, and from 2+08 to 2+15. This is a total footage of 65 LF. At STA 2+05 there is a broken pipe.

Photo 51: Fracture multiple at STA 0+37

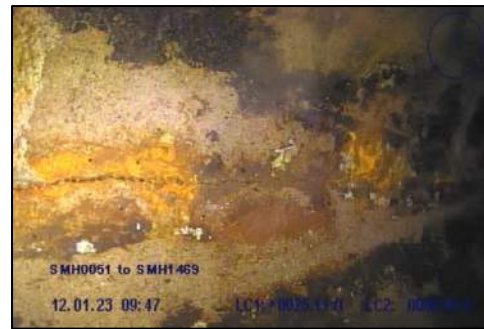
Photo 52: Fracture multiple at STA 0+25

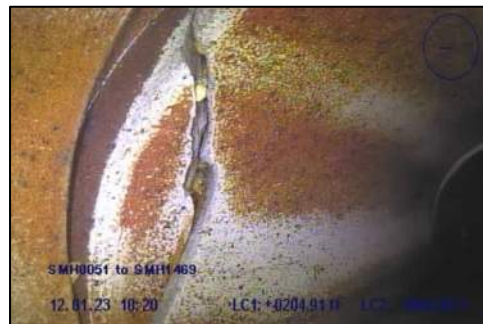
Photo 53: Broken pipe at STA 2+05

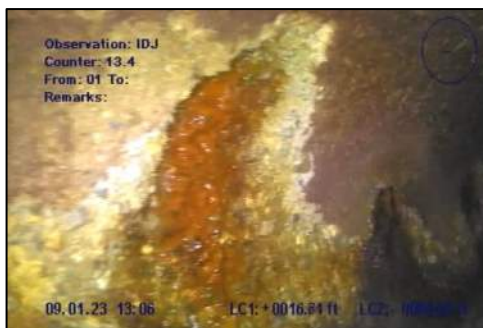
In Asset ID SP02858 (18-inch RCP), there are two sections of missing walls at STA 0+17 and STA 0+19 (observed downstream of manhole SMH1178).

Photo 54: Surface damage missing wall at STA 0+17

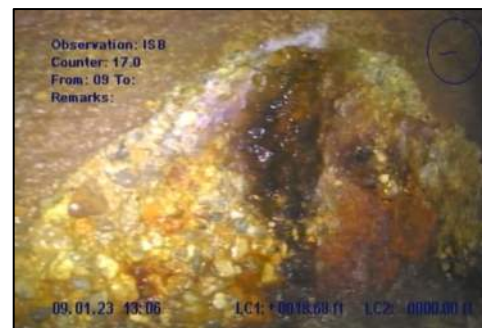
Photo 55: Surface damage missing wall at STA 0+19

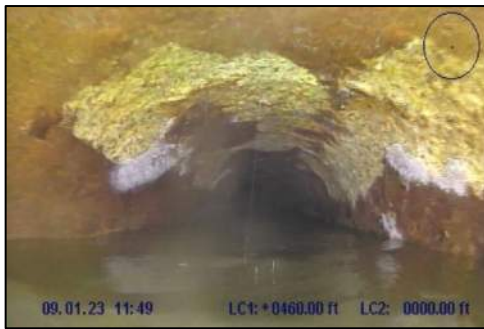
In Asset ID SP02537.A (18-inch RCP), there are multiple sections of missing walls, from STA 0+55 to STA 0+62, STA 1+56 to STA 1+62, STA 3+69, from STA 4+61 to 4+65 from STA 4+44 to STA 4+57, and from STA 4+69 to STA 4+76 (upstream of manhole SMH1178). This is a total of 38 LF.

Photo 56: Surface damage missing wall at STA 4+61

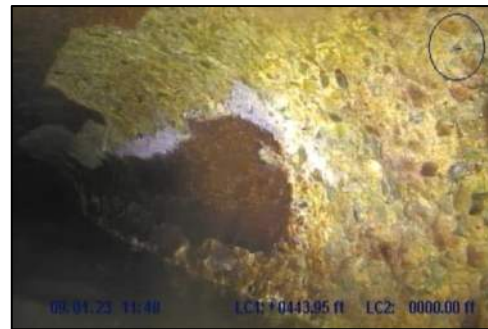
Photo 57: Surface damage missing wall at STA 4+44

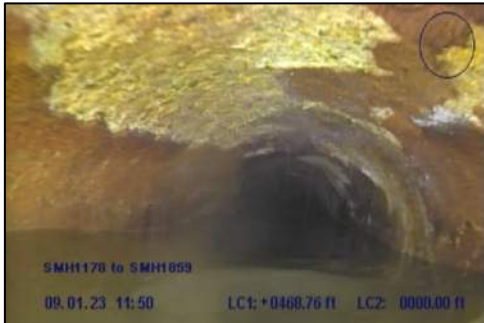
Photo 58: Surface damage missing wall at STA 4+69

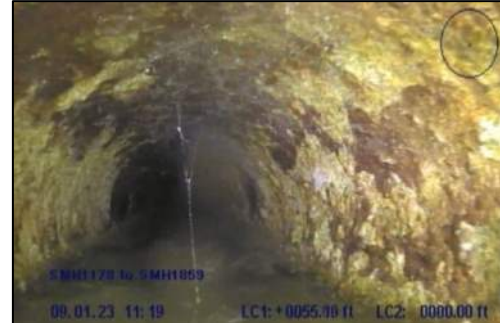
Photo 59: Surface damage missing wall at STA 0+55

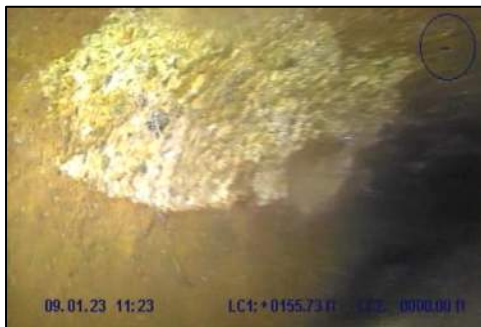
Photo 60: Surface damage missing wall at STA 1+56

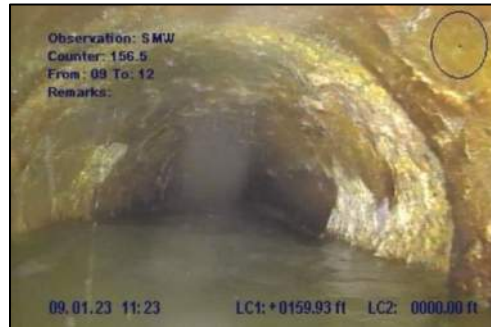
Photo 61: Surface damage missing wall at STA 1+60

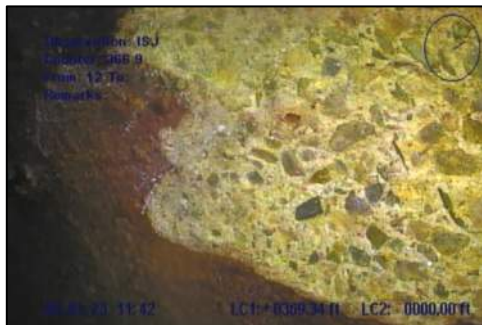
Photo 62: Surface damage missing wall at STA 3+69
