Downtown Rochester Crosswalk Assessment

**City of Rochester,
Rochester, New Hampshire**

April 2017

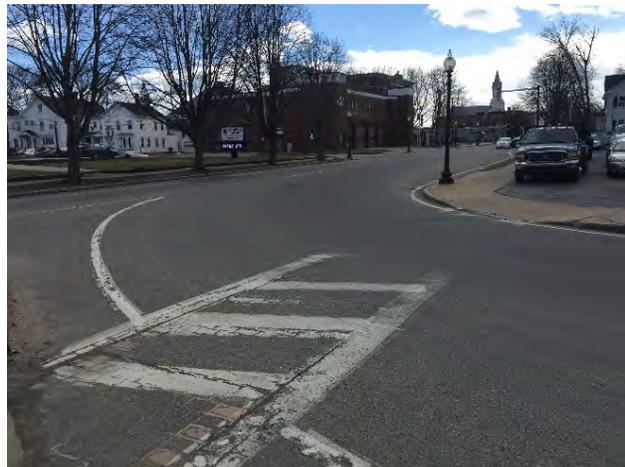
Figure 2-1: Crosswalk #2 with no signage and worn striping

All the crosswalks observed lacked one or more MUTCD recommended sign, which defines the location of pedestrian crossings, gives advanced warning to drivers, or inform pedestrians when and where they should cross the street. Figure 2-1 shows Crosswalk #2 with deteriorated markings and no pedestrian warning signs or signals.

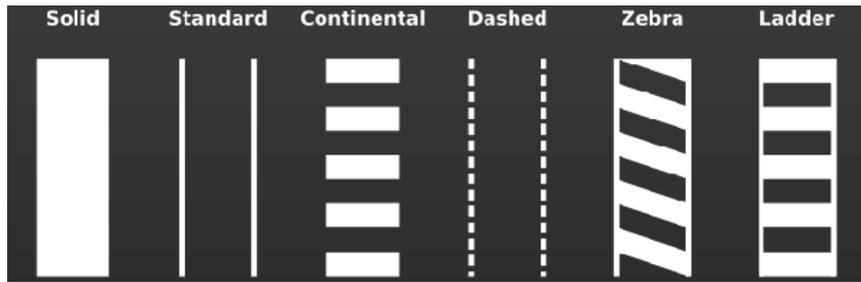
Figure 2-2: Common Pavement Markings

Crosswalk pavement markings are used to define the area where pedestrians can cross the roadway. Twenty-five of the twenty-six crosswalks observed in this assessment were striped in a zebra pattern (see Figure 2-2) and varied from 6.5

to 8.5 feet wide. There was one crosswalk observed to have a ladder striping pattern. While the crosswalks were striped with a recommended pattern and width, all the crosswalks had common deficiencies when it comes to pavement markings. These deficiencies include markings that were worn, as seen in Figure 2-1, inconsistent with respect to dimensions and materials, and some that were misaligned to the curb ramps. In some instances, the crosswalk markings were directing pedestrians into driveways instead of curb ramps.

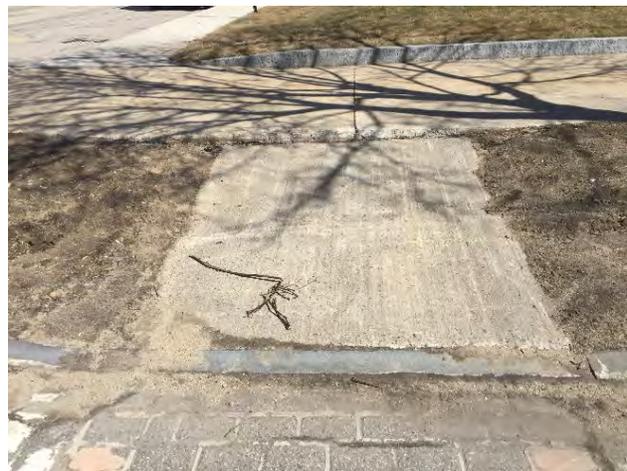
Figure 2-3: Non-ADA Compliant Curb Ramp with step

Thirty-seven (37) of the forty-two (42) curb ramps observed in this assessment had greater than the allowed 8.5% slope (in some cases exceeding 13% as shown in Figure 2-3).

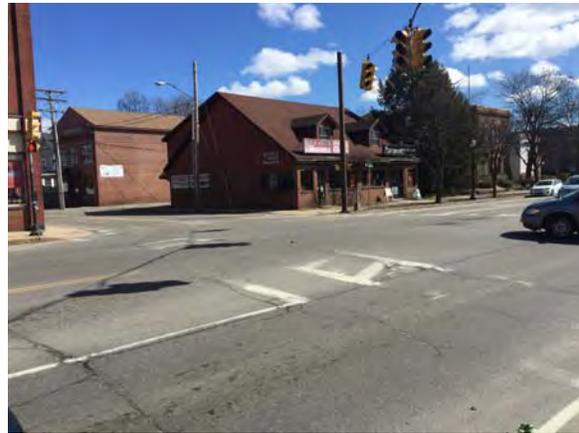
Figure 3-1: Typical Signalized Intersection (Crosswalk 8)

- **Signalized Intersections:** These intersections typically have traffic signals and push button controlled pedestrian crossing signals. (See Figure 3-1)
- **Unsignalized Intersections:** These intersections are typically stop or yield controlled on some or all of the approach legs depending on their configuration. (See Figure 3-2)
- **Mid-Block Crosswalks:** These are crosswalks located at neither a signalized nor an unsignalized intersection of two streets. Mid-block crosswalks often have curb bump outs as refuge for pedestrians who may be obscured by parked vehicles, trees, or other obstructions. (See Figure 3-3)

- Replace crossing signals that do not have audible and visual pedestrian countdown signal heads within the existing signal housing (See Figure 3-4)
- Replace or repair crossing signals that are damaged
- Add or relocate pedestrian push buttons so that they are accessible by persons in wheelchairs in compliance with the guidelines set forth in the MUTCD

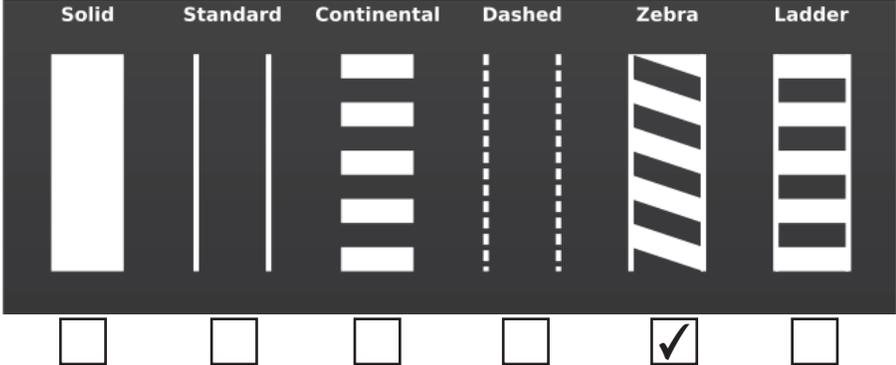
Location (Primary Street, Cross Street)	Union Street		Wakefield Street	
Crosswalk Type	Midblock <input type="checkbox"/>	Unsignalized Intersection <input checked="" type="checkbox"/>	Signalized Intersection <input type="checkbox"/>	
Zone	Commercial <input checked="" type="checkbox"/>	Residential <input type="checkbox"/>	School <input type="checkbox"/>	Other
Marking				
<u>Adjacent Parking</u>	Yes <input type="checkbox"/>	No <input checked="" type="checkbox"/>	Upstream <input type="checkbox"/>	Downstream <input type="checkbox"/>
Distance to Upstream Parking:	N/A			
Distance to Downstream Parking:	N/A			
Number of Vehicular Lanes:	1			
<u>Pattern</u>

<u>Dimensions</u>	Total Width (Edge to Edge):		6ft	6in
<u>Color</u>	White <input checked="" type="checkbox"/>	Yellow <input type="checkbox"/>	Other	
<u>Type</u>	Painted <input checked="" type="checkbox"/>	Thermoplastic <input checked="" type="checkbox"/>	Other Stamped Asphalt

<u>Reflective</u>	Yes <input checked="" type="checkbox"/>	No <input type="checkbox"/>		
<u>Condition</u>	Poor <input checked="" type="checkbox"/>	Satisfactory <input type="checkbox"/>	Good <input type="checkbox"/>	
Pedestrian Signals	Yes <input type="checkbox"/>	No <input checked="" type="checkbox"/>		
<u>Audible Signal</u>	Yes <input type="checkbox"/>	No <input checked="" type="checkbox"/>		
<u>Countdown</u>	Yes <input type="checkbox"/>	No <input checked="" type="checkbox"/>		
<u>Push Button</u>	Yes <input type="checkbox"/>	No <input checked="" type="checkbox"/>

<u>Slope</u>	<8.5% <input type="checkbox"/>	>8.5% <input checked="" type="checkbox"/>	N/A <input type="checkbox"/>	
<u>Landing</u>	Yes <input type="checkbox"/>	No <input checked="" type="checkbox"/>		
<u>ADA Detectable Strip</u>	Yes <input type="checkbox"/>	No <input checked="" type="checkbox"/>		
Curb Ramp 2	North <input type="checkbox"/>	South <input checked="" type="checkbox"/>	East <input type="checkbox"/>	West <input type="checkbox"/>
<u>Condition</u>	Poor <input checked="" type="checkbox"/>	Satisfactory <input type="checkbox"/>	Good <input type="checkbox"/>	
<u>Type</u>	Flared <input type="checkbox"/>	Parallel <input type="checkbox"/>	Returned Sides <input type="checkbox"/>	Other Flush
<u>Slope</u>	<8.5% <input checked="" type="checkbox"/>	>8.5% <input type="checkbox"/>	N/A <input type="checkbox"/>	
<u>Landing</u>	Yes <input type="checkbox"/>	No <input checked="" type="checkbox"/>		
<u>ADA Detectable Strip</u>	Yes <input type="checkbox"/>	No <input checked="" type="checkbox"/>

- Crosswalk was stamped at one time with red painted brick pattern. The color and pattern has since worn away.
- Landscaped median island is well maintained.
- Curbing shows signs of vehicle damage.

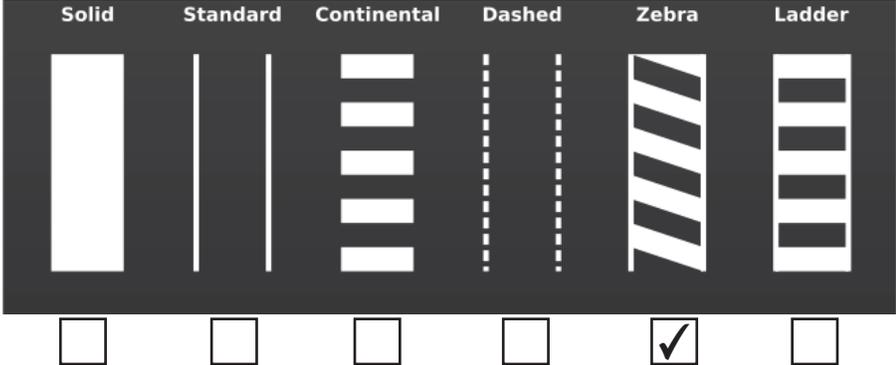
Location (Primary Street, Cross Street)	Wakefield Street		(Fire Station)		
Crosswalk Type	Midblock <input checked="" type="checkbox"/>	Unsignalized Intersection <input type="checkbox"/>	Signalized Intersection <input type="checkbox"/>		
Zone	Commercial <input checked="" type="checkbox"/>	Residential <input type="checkbox"/>	School <input type="checkbox"/>	Other	
Marking					
<u>Adjacent Parking</u>	Yes <input checked="" type="checkbox"/>	No <input type="checkbox"/>	Upstream <input type="checkbox"/>	Downstream <input checked="" type="checkbox"/>	
Distance to Upstream Parking:	N/A				
Distance to Downstream Parking:	20'				
Number of Vehicular Lanes:	2 (One-way)				
<u>Pattern</u>

<u>Dimensions</u>	Total Width (Edge to Edge): 8ft 0in				
<u>Color</u>	White <input checked="" type="checkbox"/>	Yellow <input type="checkbox"/>	Other		
<u>Type</u>	Painted <input checked="" type="checkbox"/>	Thermoplastic <input checked="" type="checkbox"/>	Other Stamped Asphalt

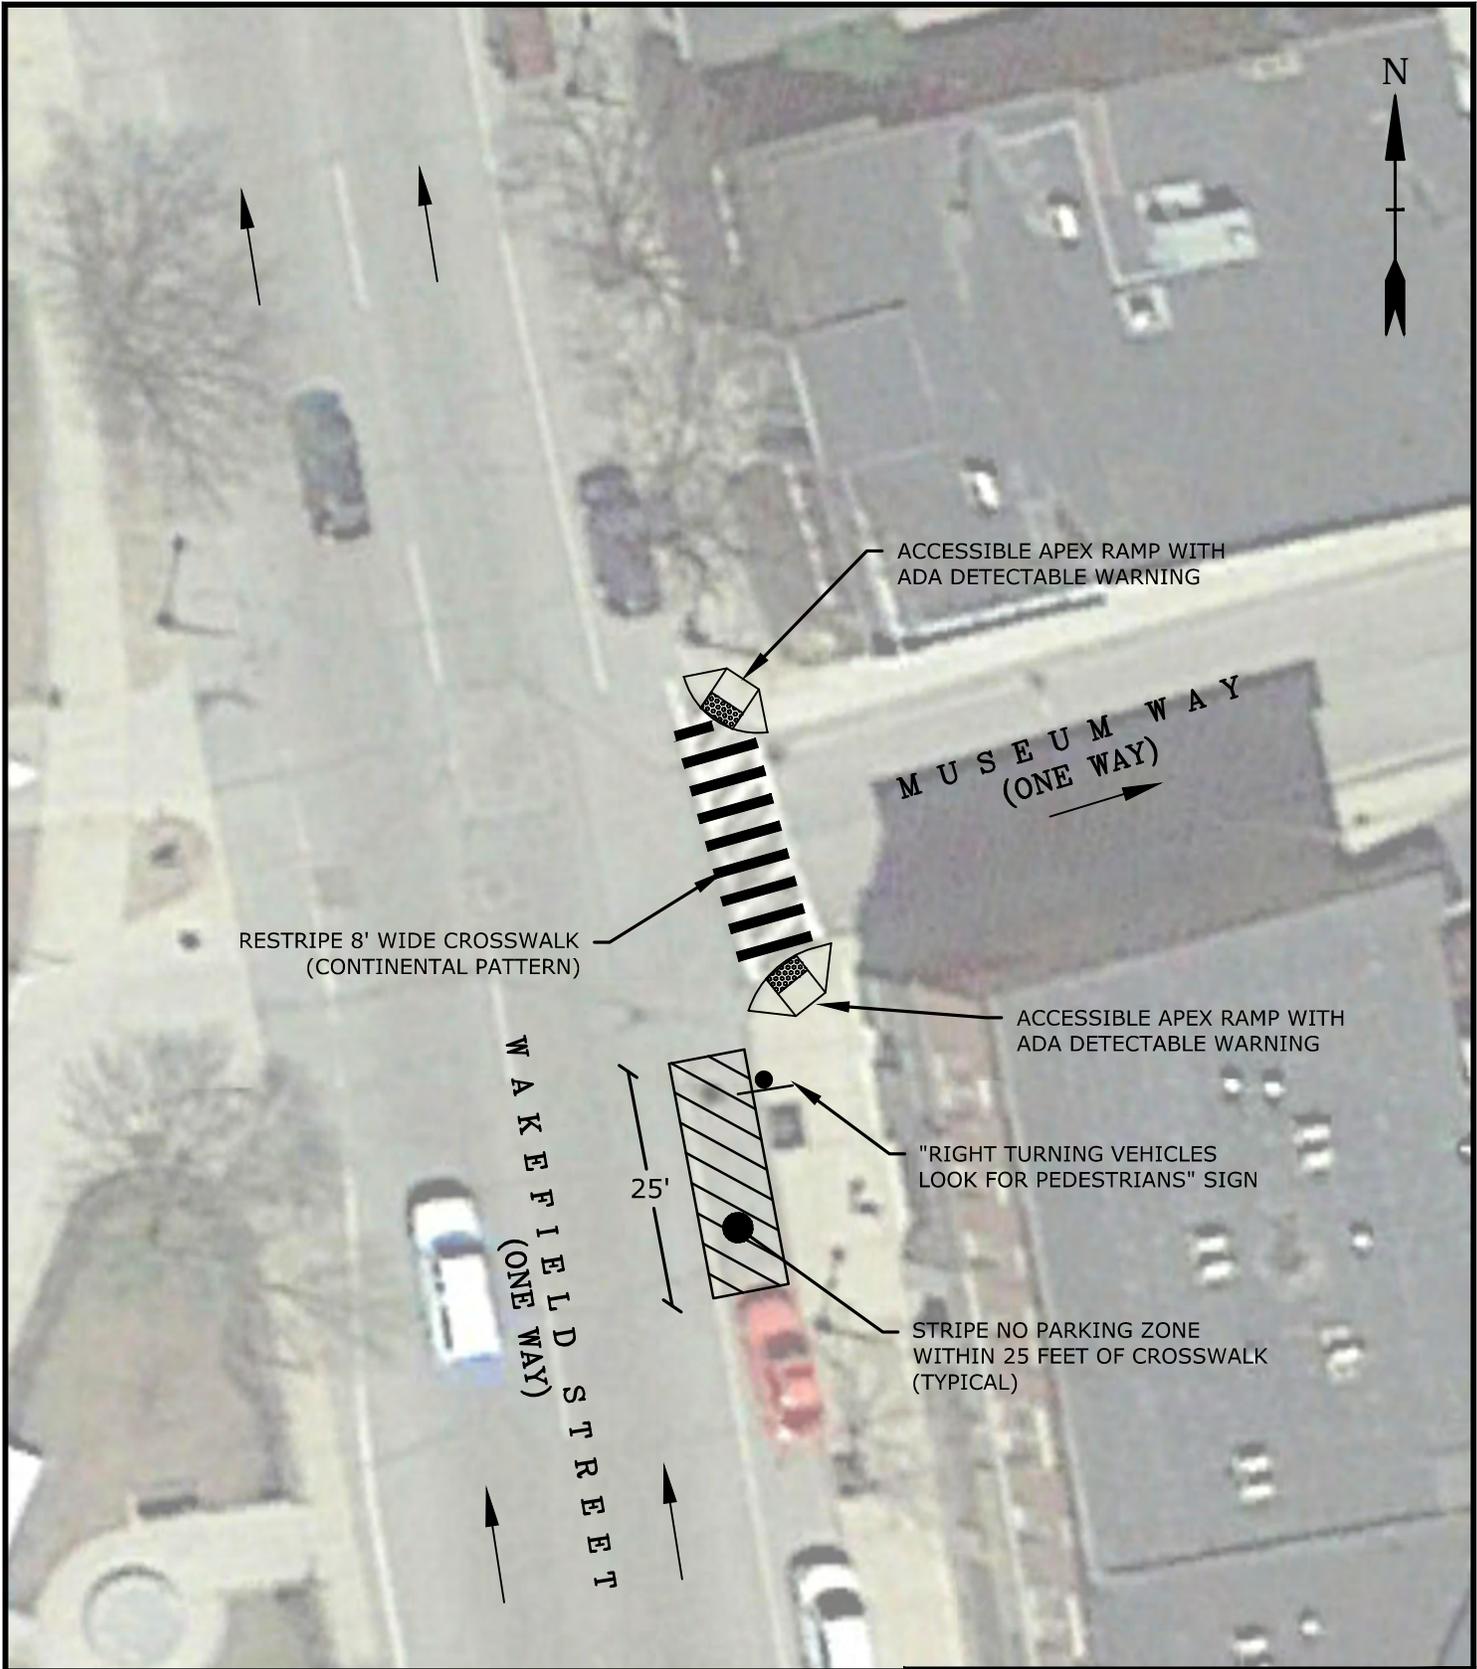
CROSSWALK 4B	
CROSSWALK ASSESSMENT ROCHESTER, NH	
DATE: 3/30/2017	Tighe & Bond <i>www.tighebond.com</i>
SCALE: AS SHOWN	
EXHIBIT 6

1. THIS EXHIBIT REPRESENTS CONCEPTUAL IMPROVEMENTS TO THIS CROSSWALK. FIELD VERIFICATION OF EXISTING FEATURES AND ENGINEERING DESIGN OF CURB RAMPS SHOULD BE PERFORMED PRIOR TO CONSTRUCTION.

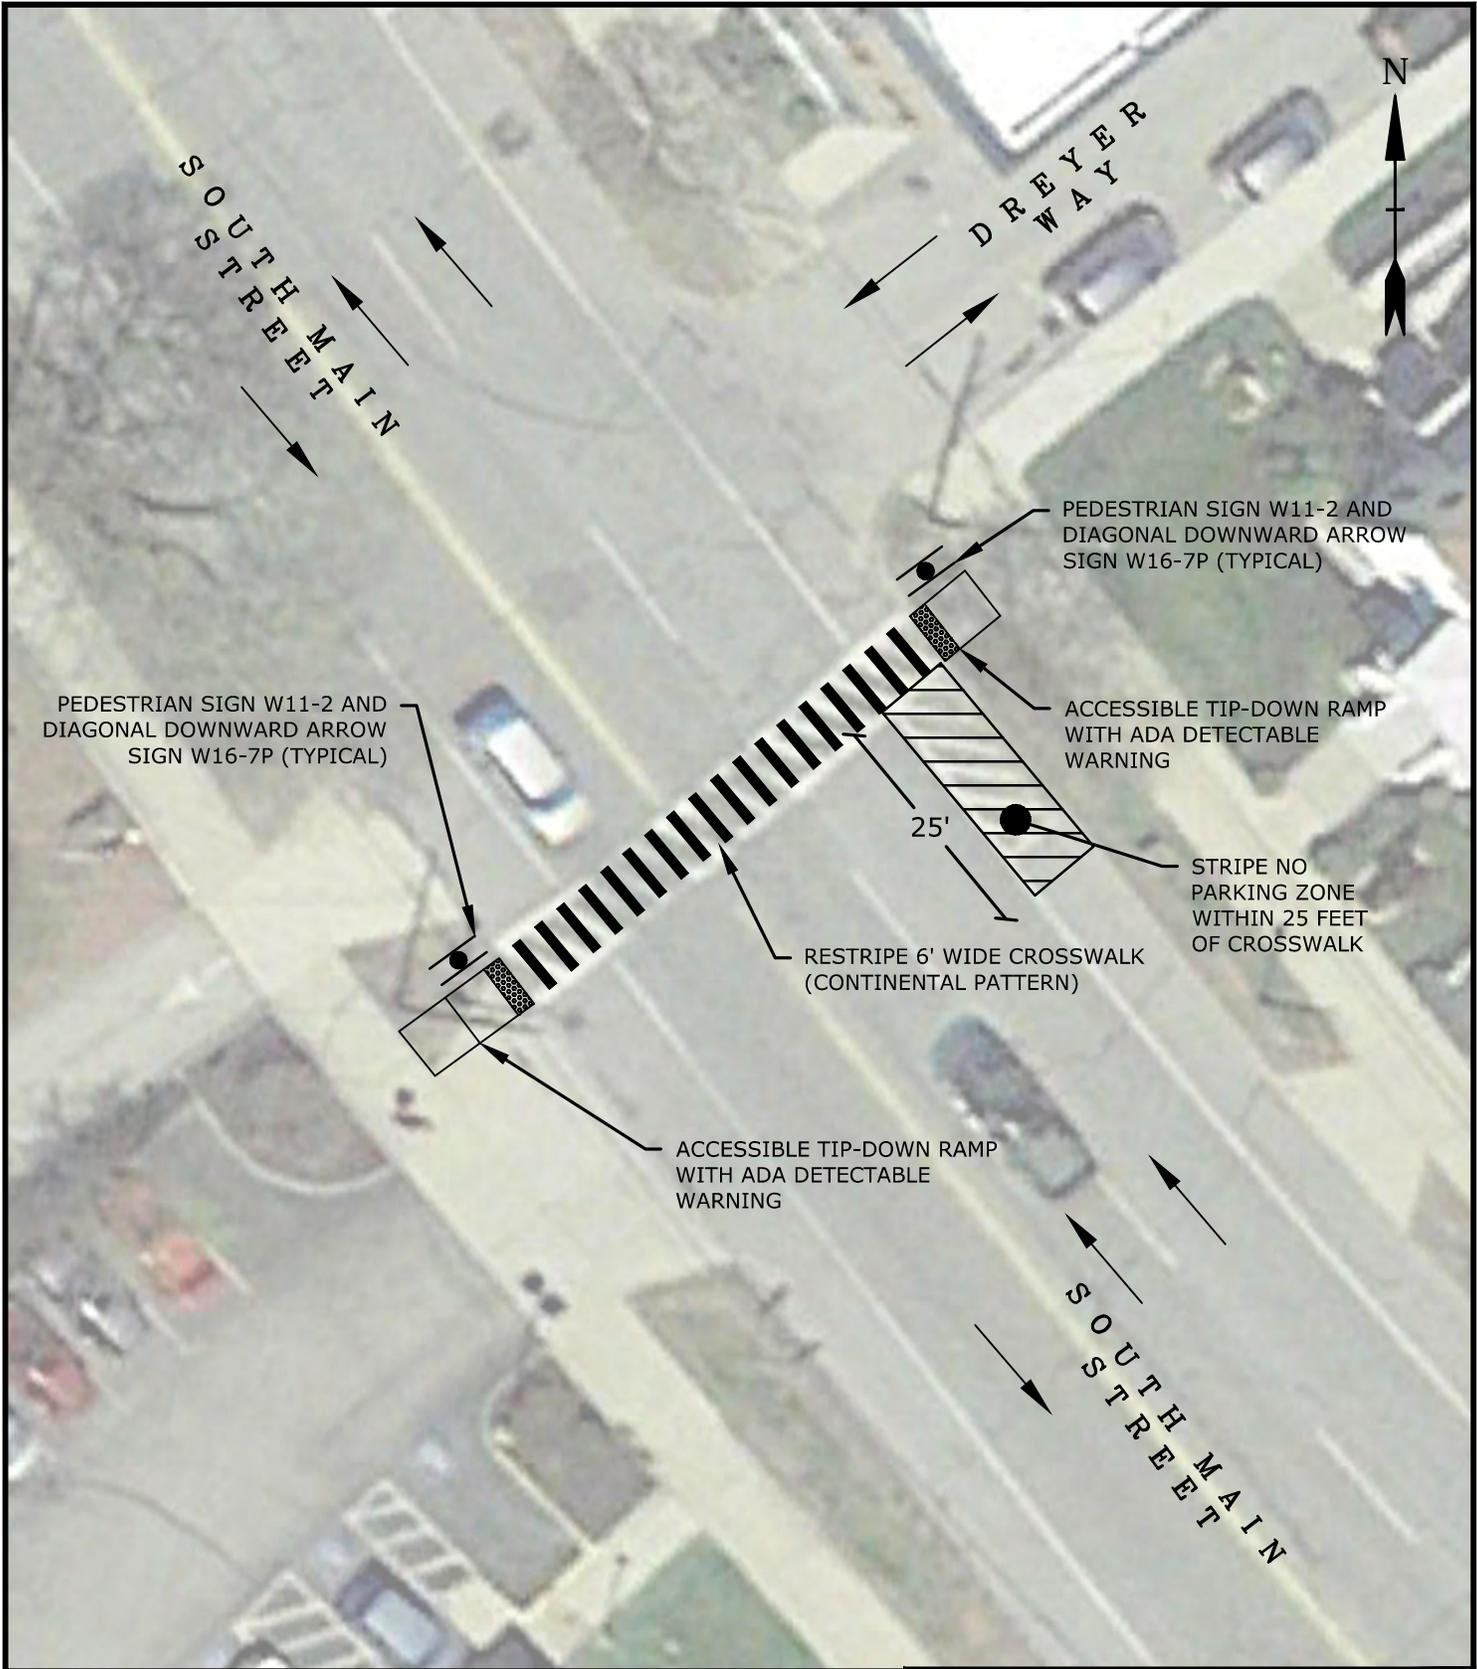
CROSSWALK 9B	
CROSSWALK ASSESSMENT ROCHESTER, NH	
DATE: 3/30/2017	Tighe & Bond www.tighebond.com
SCALE: AS SHOWN	
EXHIBIT 17

1. THIS EXHIBIT REPRESENTS CONCEPTUAL IMPROVEMENTS TO THIS CROSSWALK. FIELD VERIFICATION OF EXISTING FEATURES AND ENGINEERING DESIGN OF CURB RAMPS SHOULD BE PERFORMED PRIOR TO CONSTRUCTION.
