HISTORIC PRESERVATION PROGRAM - STRAFFORD ROCKINGHAM REGIONAL COUNCIL  
One Water Street, Exeter, New Hampshire 03833 Phone: (603)778-0885

SURVEY NUMBER: 74

COMMON NAME: First Congregational Church

LOCATION: S. Main Street

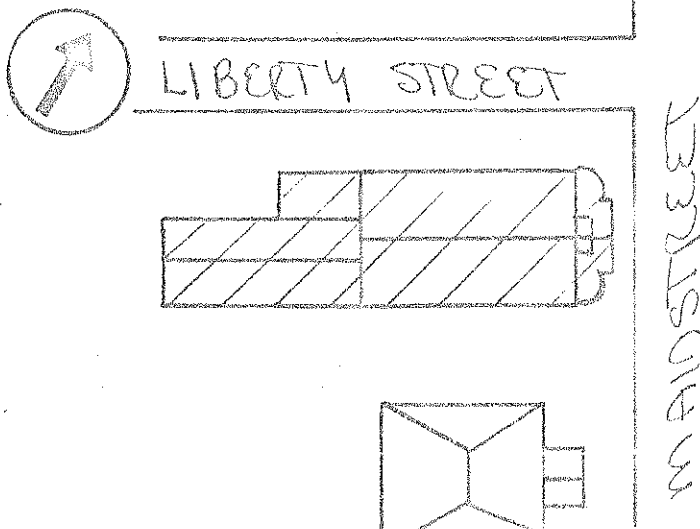
PHOTO

Description of View: Facade, looking West.

The First Congregational Church displays an interesting blend of architectural elements. The original building consisted of the first 3 bays of the main block, the pedimented pavillion centered on the facade, and the base of the tower. The modillioned cornice along the eaves on the side elevations is an original Federal style feature.

The corners of the entry pavillion and tower are emphasized by notched pilasters, Greek Revival style features possibly added when the building was moved to this site in 1842.

The church was enlarged in 1867. At that time several additions were made. A fourth bay was added to the main block, and polygonal-shaped wings attached on either side of the entry pavillion. The entry was given an Italianate door topped by a semicircular fanlight and half-round cap. The fanlight contains elaborate on stained glass with "First Congregational Church" worked into the design. The stained glass dates to a later period. Above the doorway is a round-headed window
