HISTORIC PRESERVATION PROGRAM - STRAFFORD ROCKINGHAM REGIONAL COUNCIL
One Water Street, Exeter, New Hampshire 03833 Phone: (603)778-0885

TOWN: Rochester	COUNTY: Strafford	UTM: Z 19 /E 339490 /N 4796410
SURVEY NUMBER: 7		USGS QUAD: Berwick Quad 15' series
COMMON NAME: The Needle Works		FUNCTIONAL TYPE: Commercial/Residential
HISTORIC NAME: Unknown		PRESENT USE: Commercial/Residential
LOCATION: 91 North Main Street		ARCHITECT/BUILDER: Unknown
OWNER: Capodestria Realty Co.		CONDITION: Exc. ___ Good <input checked="" type="checkbox"/> Fair ___ Poor ___ Ruins ___
ADDRESS: 6 Union Street Rochester, NH		INTEGRITY: Original Site <input checked="" type="checkbox"/> Moved ___ Date ___
MAP & PARCEL #: 42/255 121-368-1		Major Alterations & Date:
DATE: C.1895-1900		
SOURCE: Inspection		
STYLE: Late Victorian Commercial		LEVEL/SIGNIFICANCE: Natl. ___ State ___ Local ___

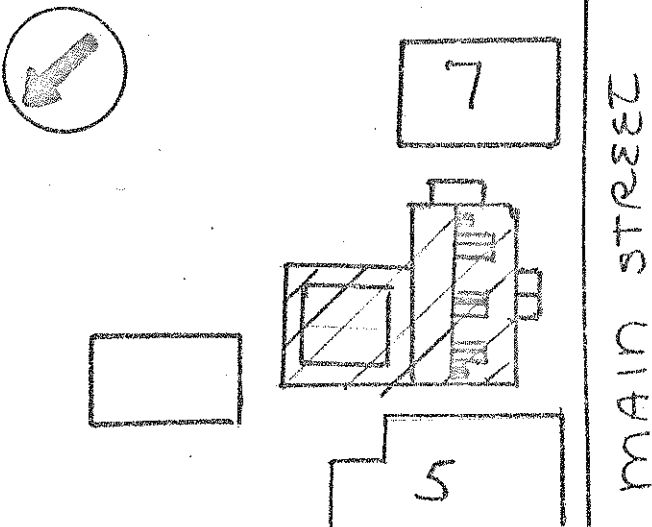
PHOTO

Description of View: Three Quarter Looking East
Negative File Number: R-80-A1-32
Photographer: Roger Brevoort
Negative on file with: SRRC

Dating C.1895 - 1900, this is a late Victorian commercial building distinguished by a bracketed cornice and two oriel windows on the second story of the facade. Significantly, the storefront has escaped alteration, with a recessed central entry being flanked by plate glass display windows in wooden frames. Aluminum siding obscures any other exterior ornamentation.
