HIDIUKIU PKESEKVALIUN ASSISTANCE PKOJECI

Strafford Rockingham Regional Council

COUNTY: Strafford TOWN: Rochester SURVEY NUMBER: COMMON NAME: Borque's Flooring HISTORIC NAME: The Chesley Building LOCATION: 47 North Main Street OWNER: Richard L. Allard ADDRESS: First Crown Point Rd., Strafford. NH 03884-MAP & PARCEL #: 42/285 191-373 DATE: C. 1870 SOURCE: Inspection STYLE: Italianate

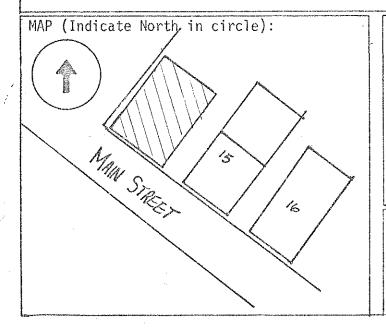
РНОТО

Description of View: Facade looking east

This C. 1870 Italianate style commercial block is identified now primarily by its projecting block cornice which is supported on three pairs of incised consule brackets. A similiar cornice runs above the storefront level, supported by paired brackets at the ends and a single bracket at the center.

Both cornices are wood. Paneled pilasters flank the facade on the upper story, but are presently covered at the storefront level. The storefront also may remain unaltered behind the aluminum. The existing plate glass display windows and transoms, framed in wood, flank a recessed central entry, reflecting the proper original design. The upper story is flush boarded, a common nineteenth century measn of giving buildings more formal facade.

The wide plate glass window is a twentieth century alteration.
