# **NHDES WETLANDS BUREAU WETLAND RESTORATION PLAN**

**60 Shaw Drive  
Rochester, NH 03867  
Map 240, Lot 49  
&  
Shaw Drive  
Rochester, NH 03867  
Map 240, ROW**

**Re: NHDES Proposed Wetland Restoration Plan  
Shaw Drive, Rochester, NH 03867**

Project Name: Shaw Drive Wetland Restoration

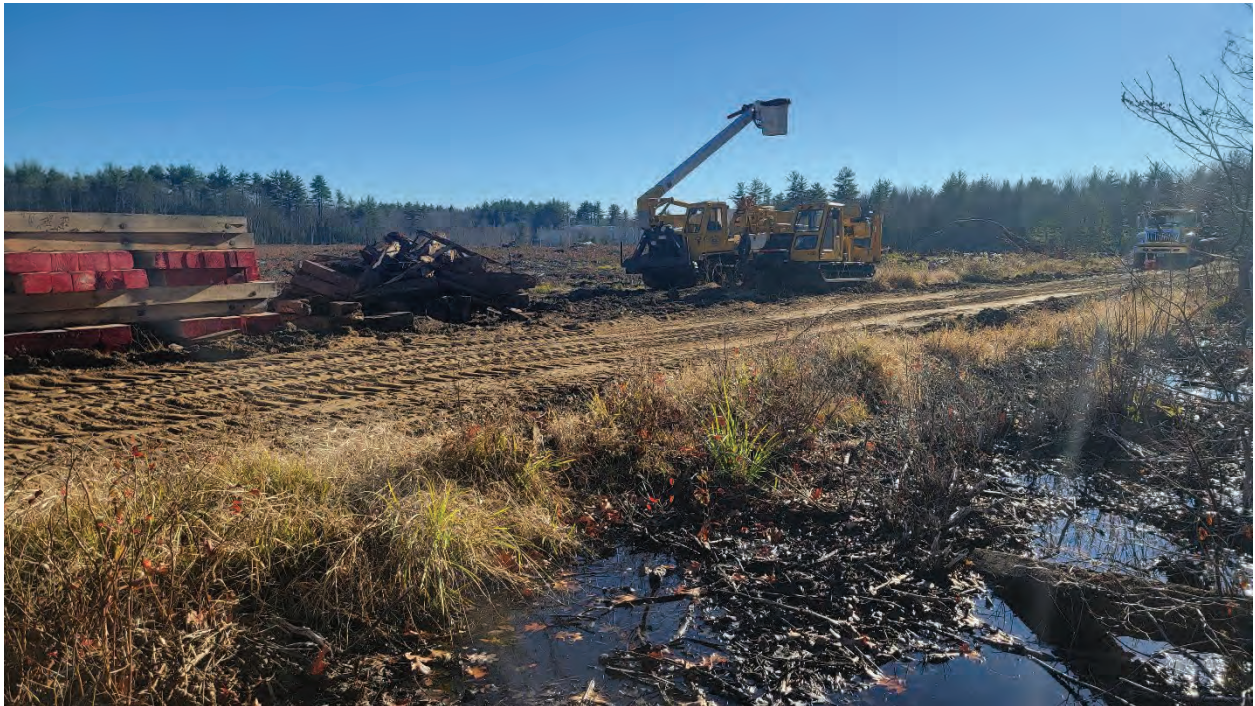
Photo 1 – Wetland Restoration Area #1 – View southeast from the west side of Shaw Drive in Wetland B and along Wetland Restoration Area #1, which proposes restoration work along Shaw Drive and within Wetland B on the property (Map 240, Lot 49) (photo taken 11/10/22).

Proposed wetland restoration area #1 is located within the middle of the site in Wetland B and extends to and across Shaw Drive. The restoration area includes significant disturbance from forestry work (NHDES File No. 2022-00571) and the installation of Shaw Drive through Shaw Drive. The total area of proposed wetland restoration area #1 51,675 square feet (1.19 Acres). The proposed wetland restoration will remove fill along Shaw drive, regrade the area of impacted wetland, seed the wetland area with native seed mix, and plant native shrubs. Restoration along Shaw Drive will restore wetland edges along the roadway that were disturbed during the installation. Restoration of forestry impacts will involve grading of rutting from forestry equipment. For more details see below.

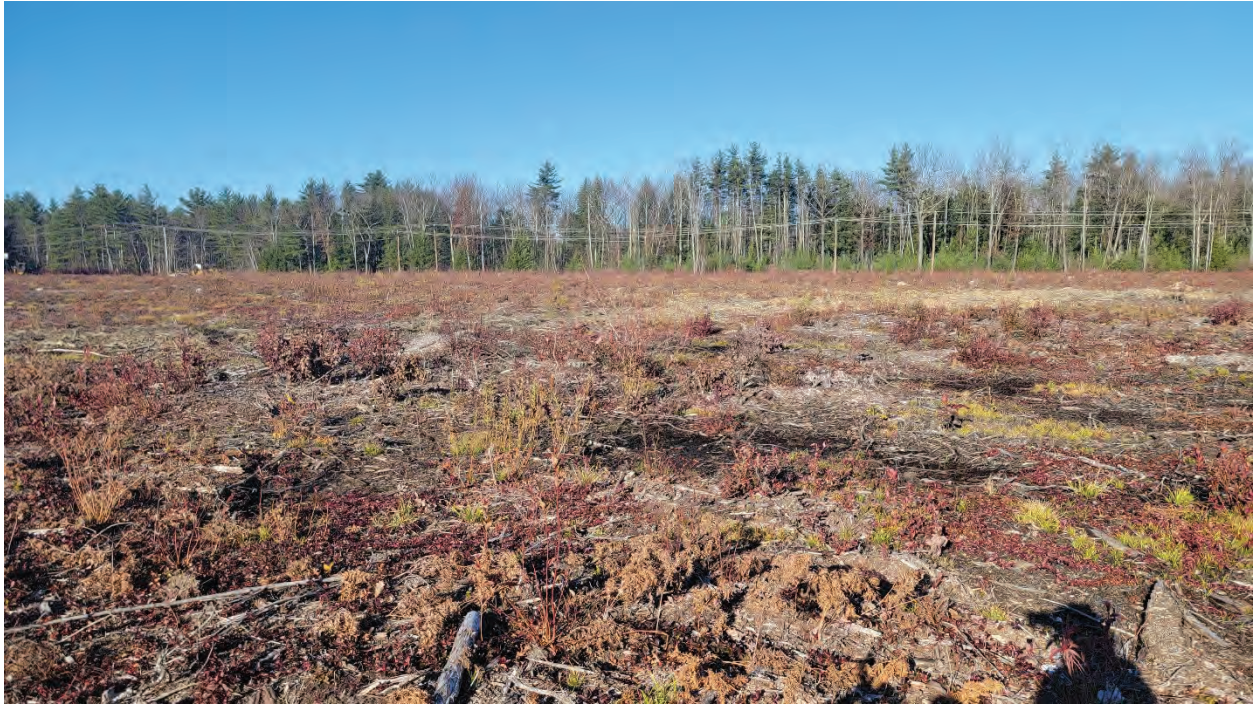
Photo 2 – Wetland Restoration Area #1 – View north into Wetland B in the center of the property (Map 240, Lot 49) where the majority of Wetland B has been disturbed and requires restoration to regrade, seed, and plant shrubs (photo taken 11/10/22).

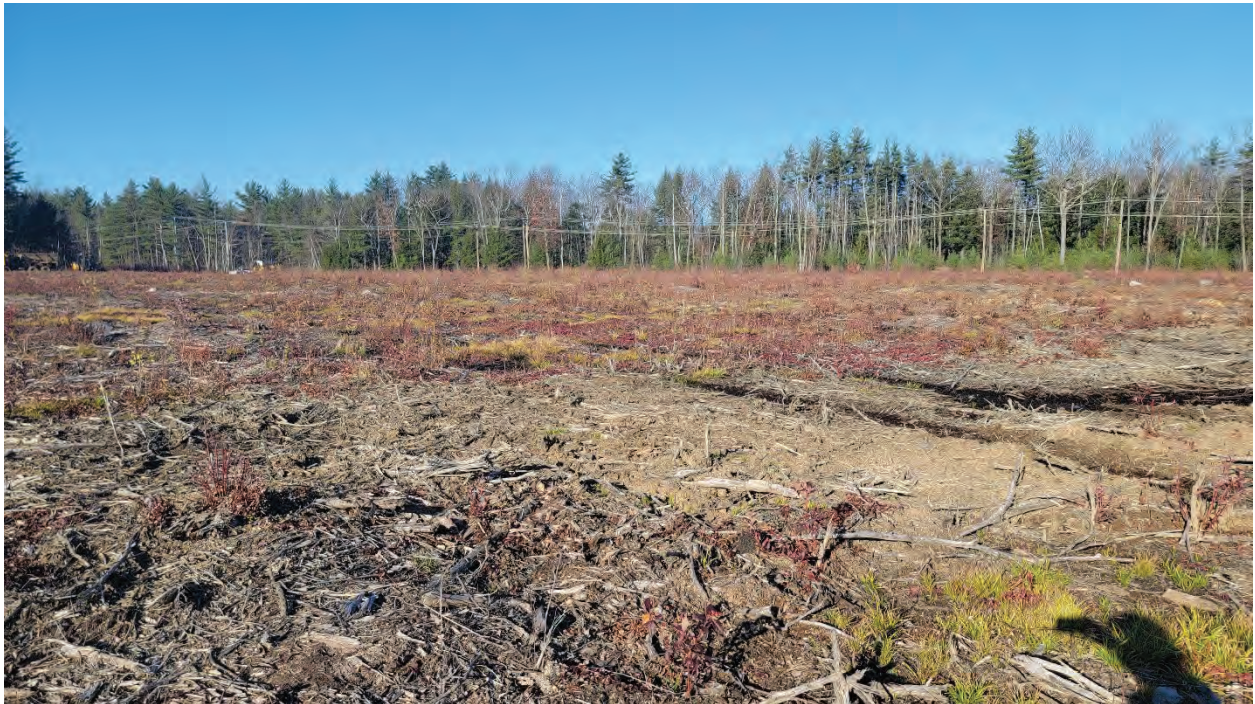
Photo 3 – Wetland Restoration Area #1 – Additional view northeast into Wetland B which has been greatly disturbed with the property (Map 240, Lot 49) (photo taken 11/10/22).

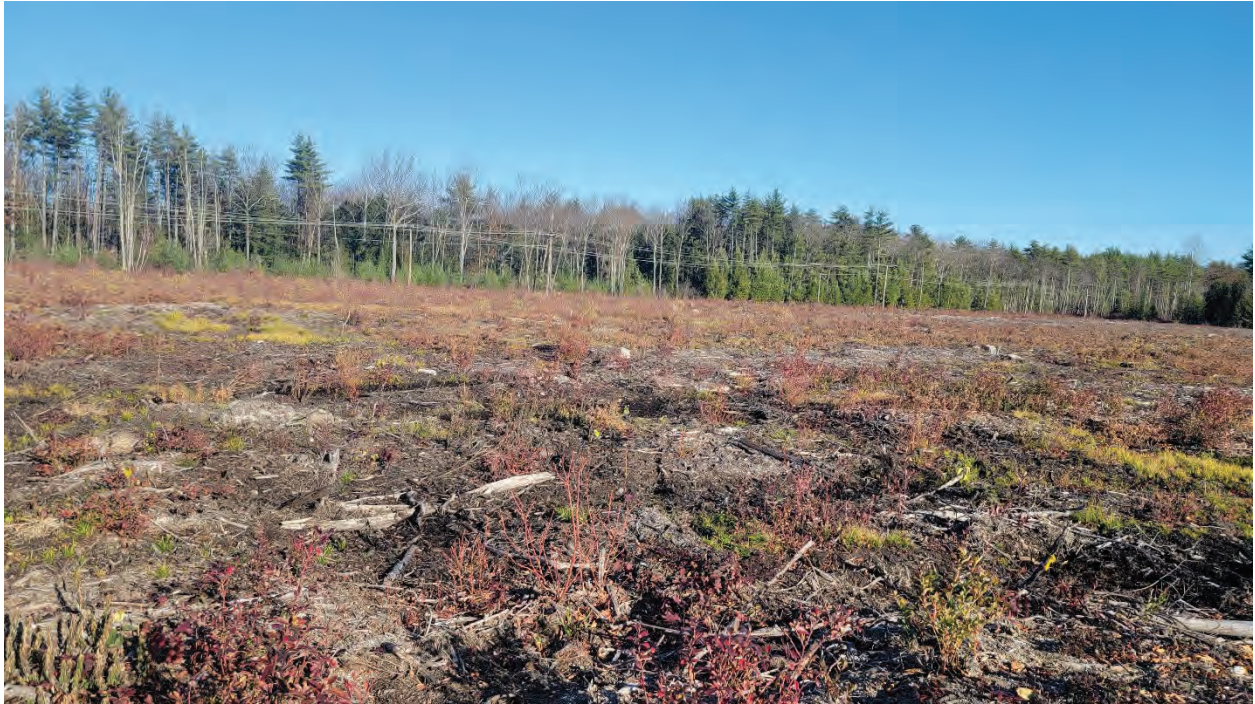
Photo 4 – Wetland Restoration Area #1 – Continued view to the northeast of disturbance of Wetland B on the property (Map 240, Lot 49) (photo taken 11/10/22).

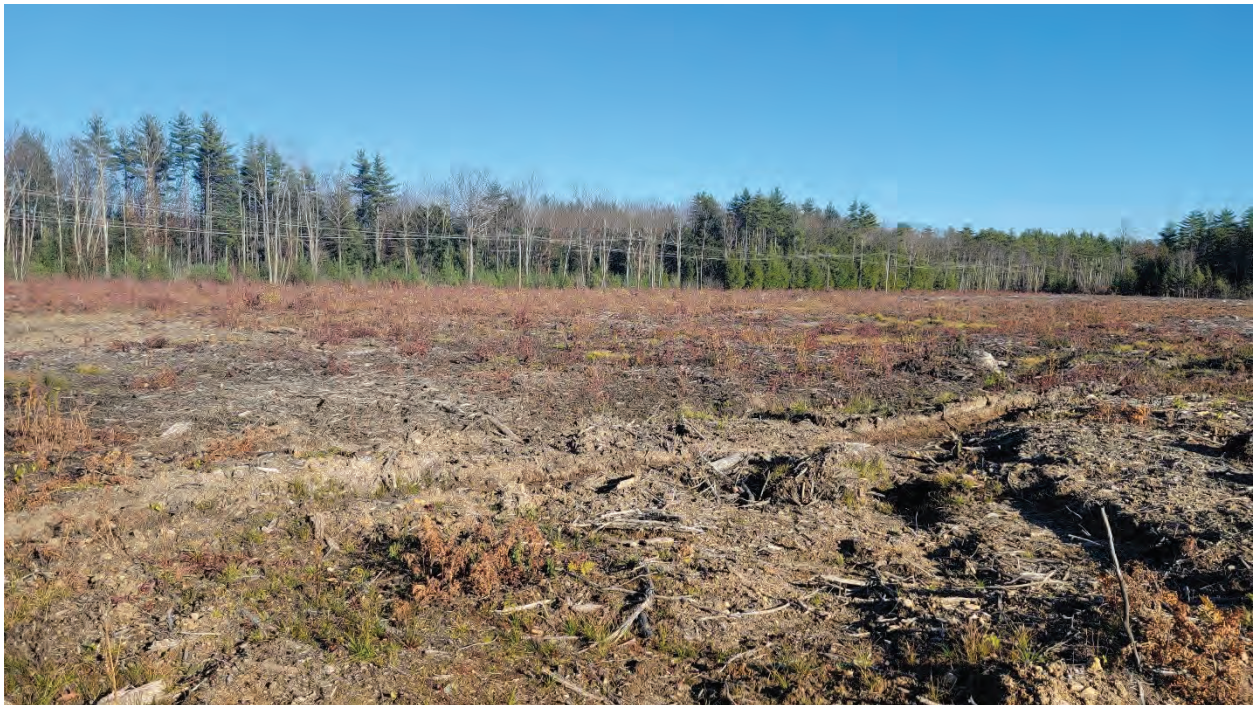
Photo 5 – Wetland Restoration Area #1 – Continued view to the northeast of disturbance of Wetland B on the property (Map 240, Lot 49) (photo taken 11/10/22).

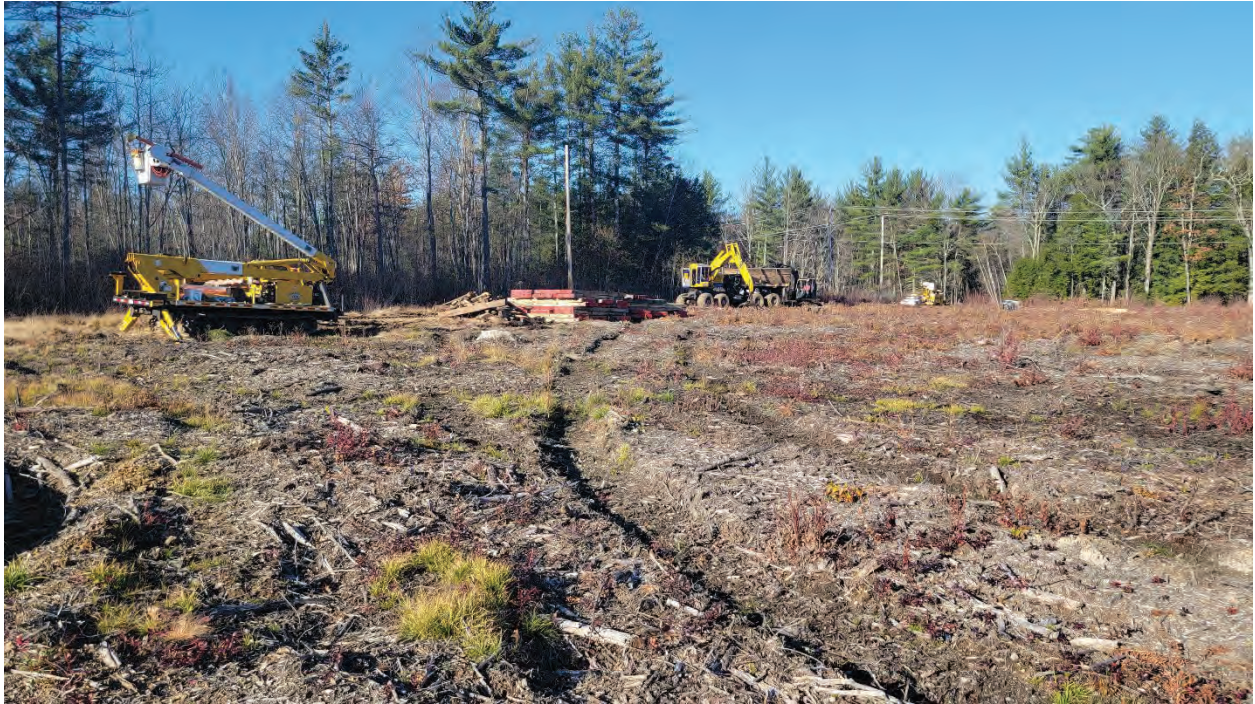
Photo 6 – Wetland Restoration Area #1 – View north along Wetland B south edge and towards proposed Wetland B impact on Shaw Drive (photo taken 11/10/22).

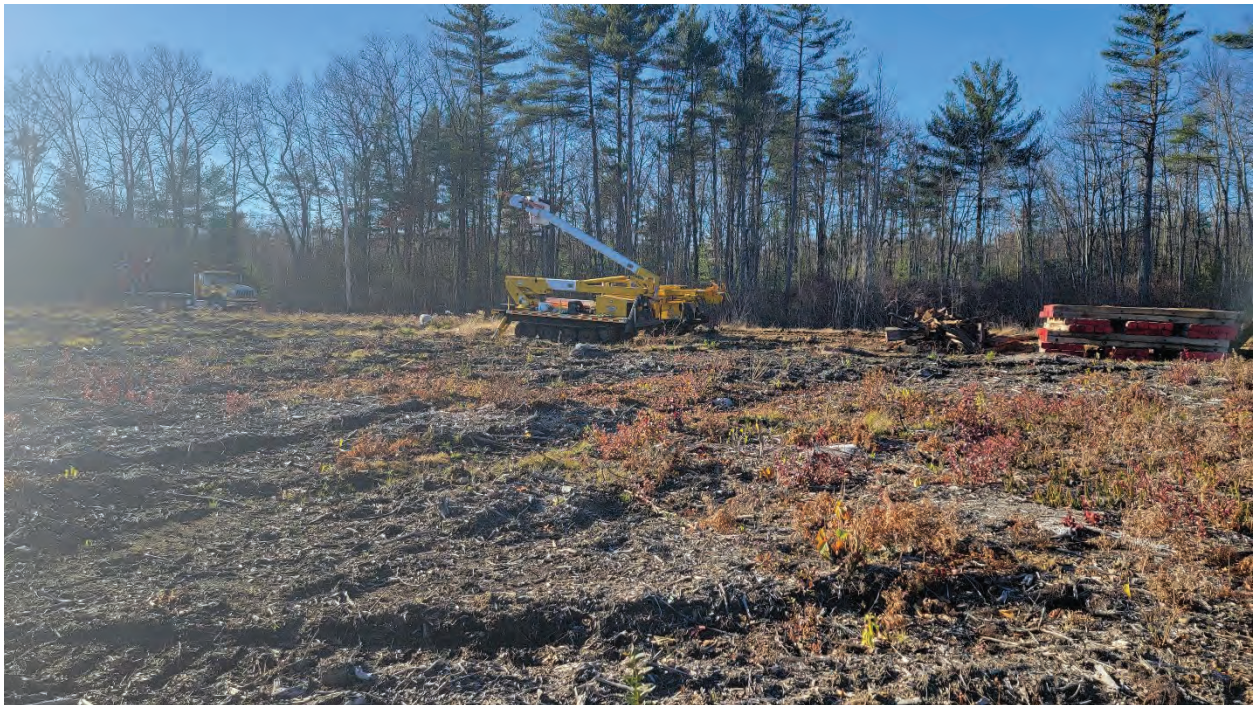
Photo 7 – Wetland Restoration Area #1 – View north along Wetland B south edge and towards proposed Wetland B impact on Shaw Drive (photo taken 11/10/22).

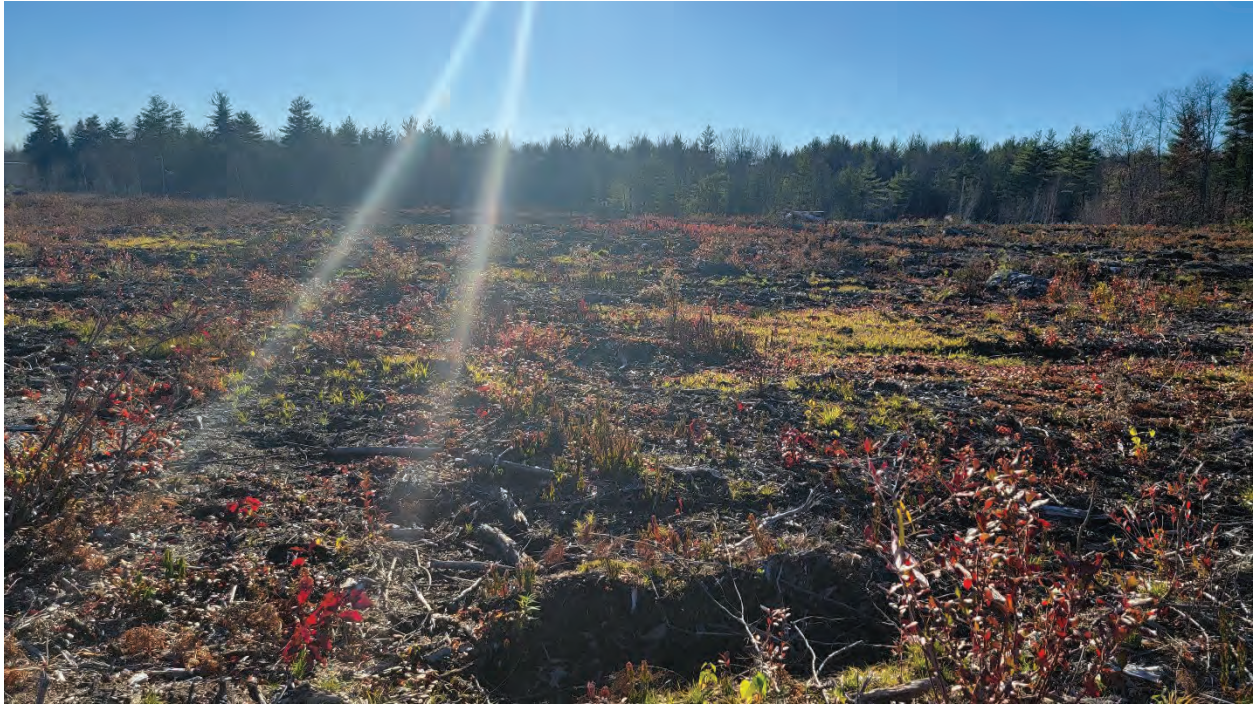
Photo 8 – Wetland Restoration Area #1 – Additional view to the south of the disturbance in Wetland B in the center of the property (Map 240, Lot 49) (photo taken 11/10/22).

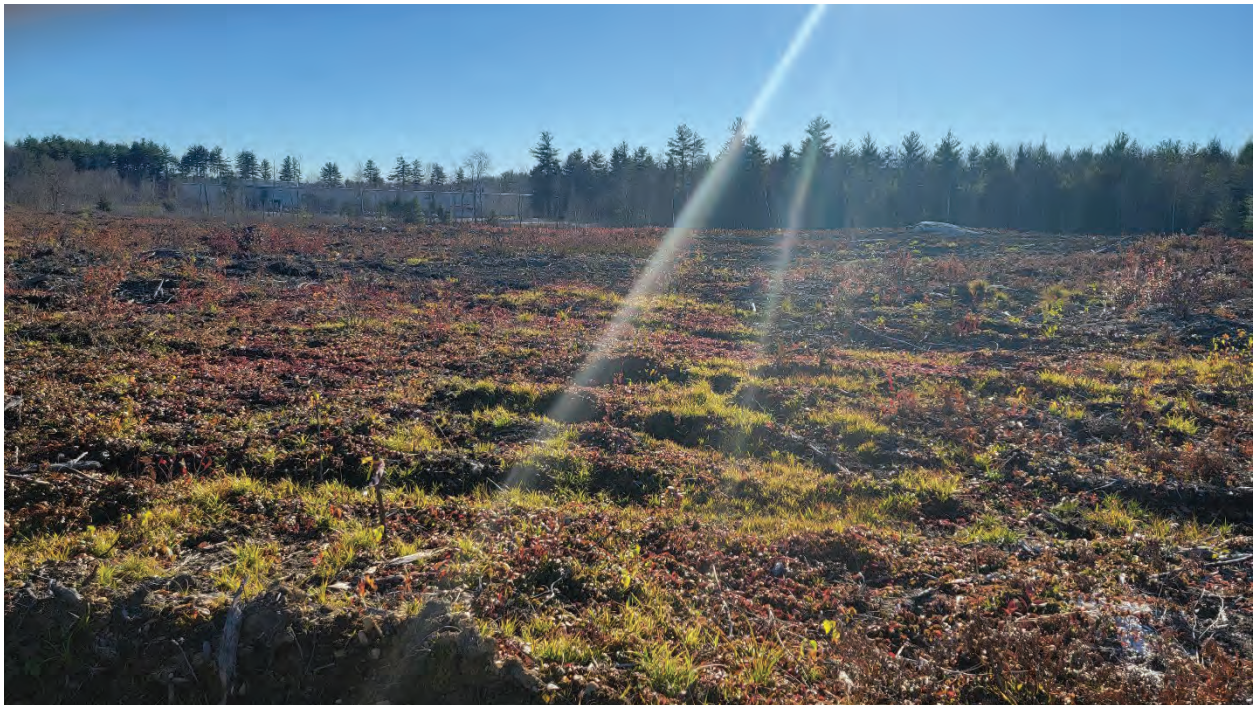
Photo 9 – Wetland Restoration Area #1 – Additional view of disturbance near end of Wetland B in the center of the property (Map 240, Lot 49) (photo taken 11/10/22).

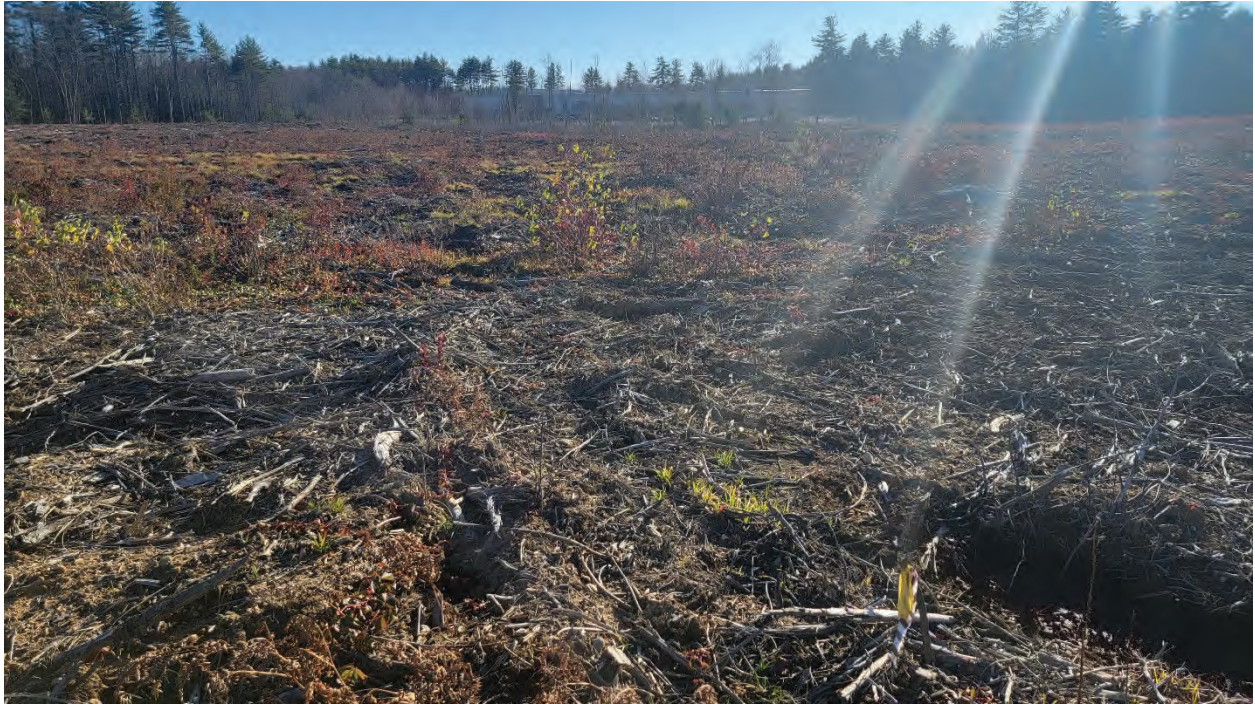
Photo 10 – Wetland Restoration Area #1 – Additional view south across Wetland B which requires a large area of restoration (photo taken 11/10/22).

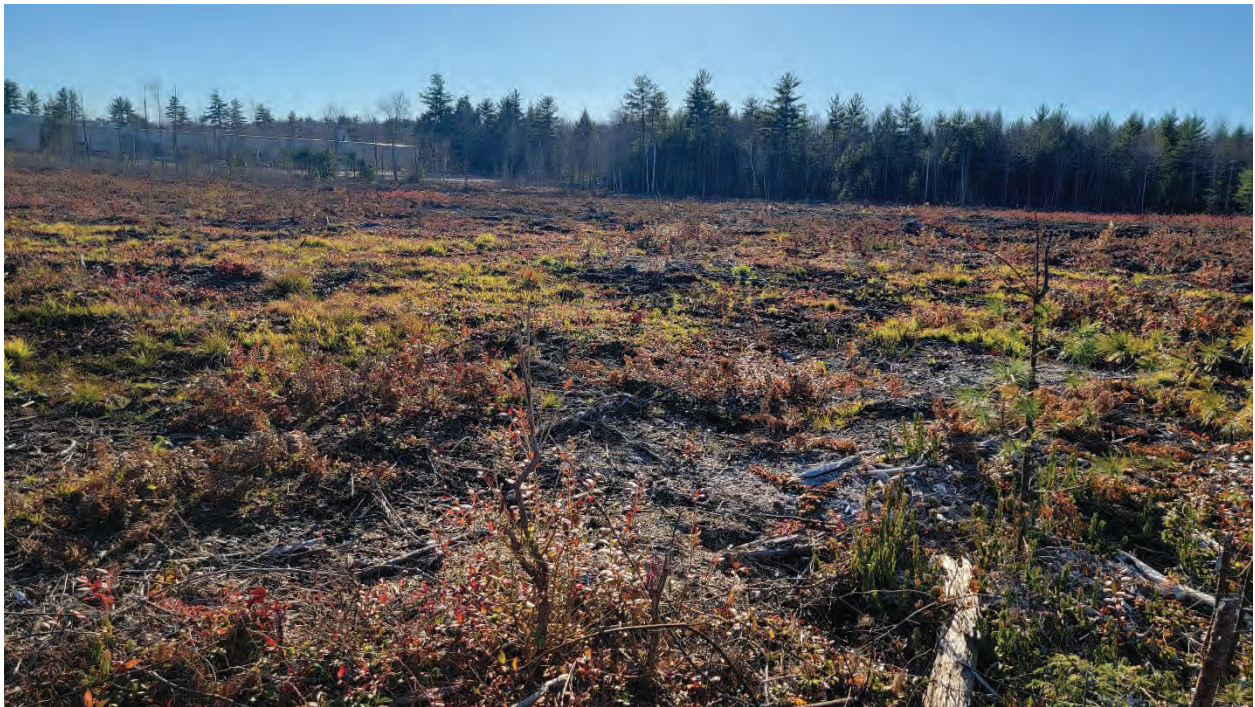
Photo 11 – Wetland Restoration Area #1 – Additional view south across wetland B disturbance (photo taken 11/10/22).

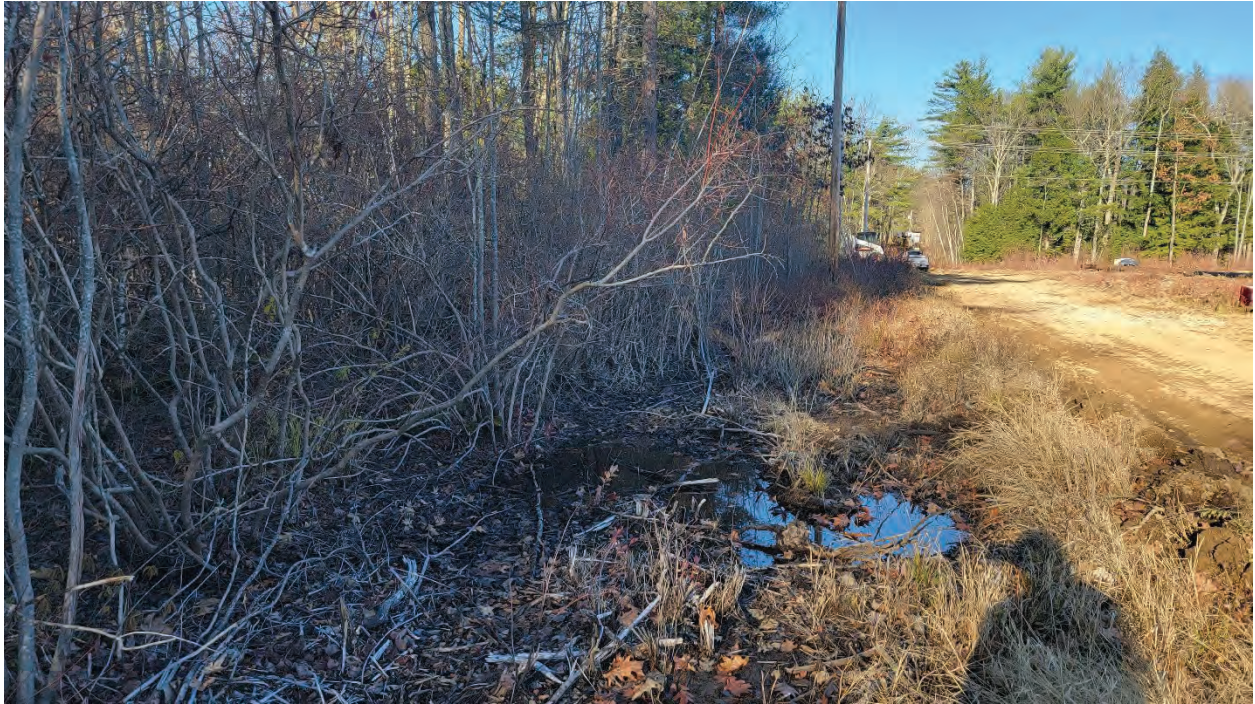
Photo 12 – Wetland Restoration Area #1 – View northeast along the west side of Shaw Drive of where restoration is proposed as part of Restoration Area #1 (photo taken 11/10/22).

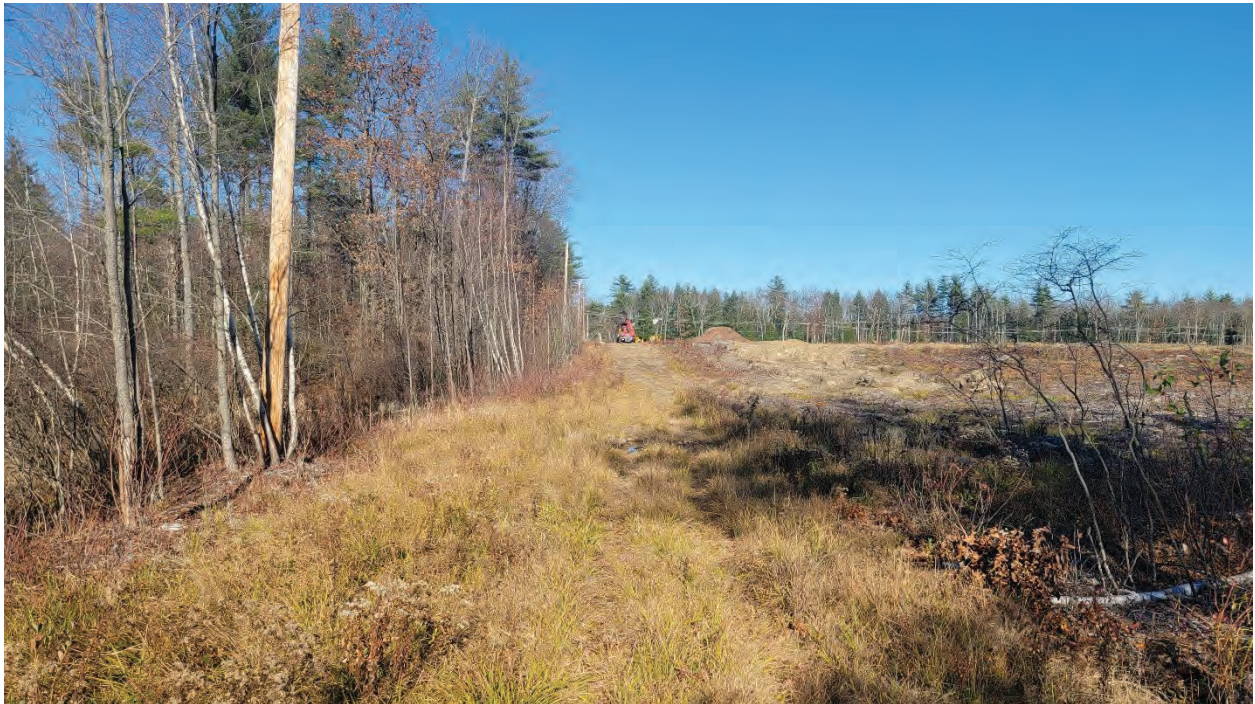
Photo 13 – Wetland Restoration Area #2 – View northeast along Shaw Drive near the southwest corner of the property (Map 240, Lot 49) and Restoration Area #2 which proposes restoration along the edges of Shaw Drive (photo taken 11/10/22).

Proposed wetland restoration area #2 is located within the ROW in Wetland B along of Shaw Drive and along the edge of Lot 49 in the southwest corner of the site. Shaw Drive has been installed across a portion of Wetland B and requires restoration along the edges of the road. The total area of proposed wetland restoration area #2 83,704 square feet (1.9 AC). The proposed wetland restoration will remove fill, regrade the area of impacted wetland, seed the wetland area with native seed mix. For more details see below.

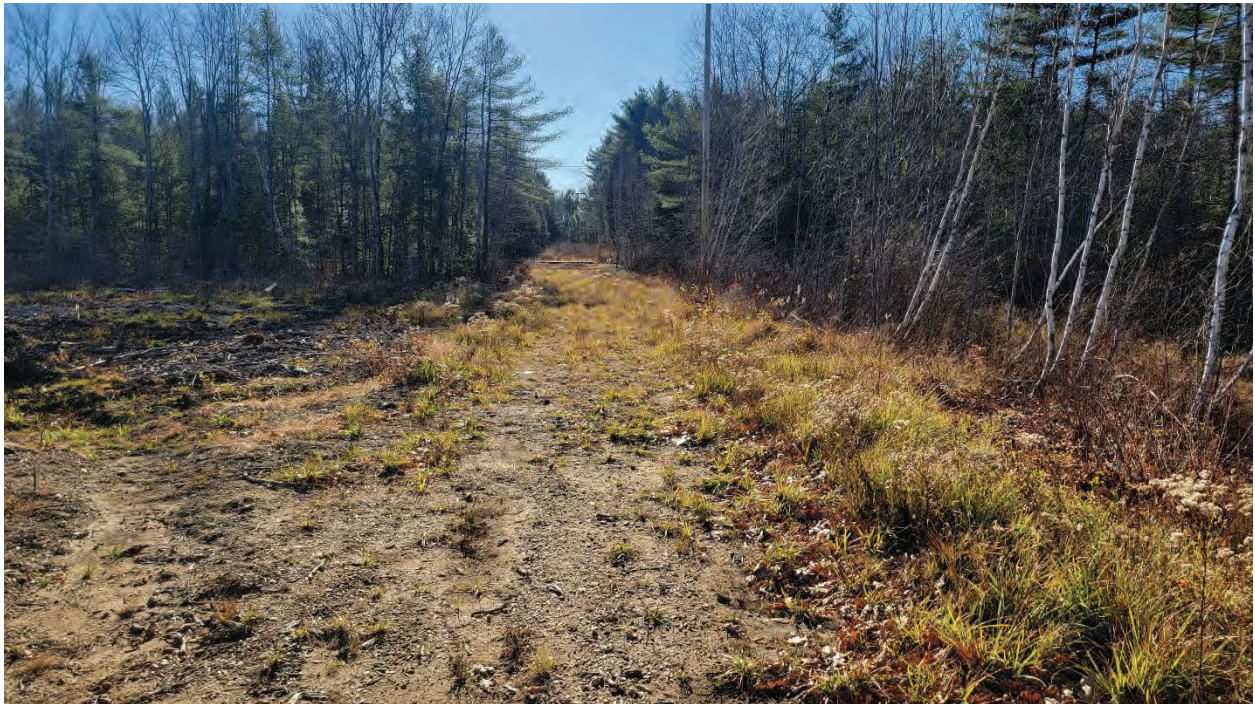
Photo 14 – Wetland Restoration Area #2 – View southwest along Shaw drive near the southwest corner of the property (Map 240, Lot 49) and across proposed Wetland Impact Area C. Restoration is proposed along the edges of Shaw Drive (Restoration Area 2) (photo taken 11/10/22).

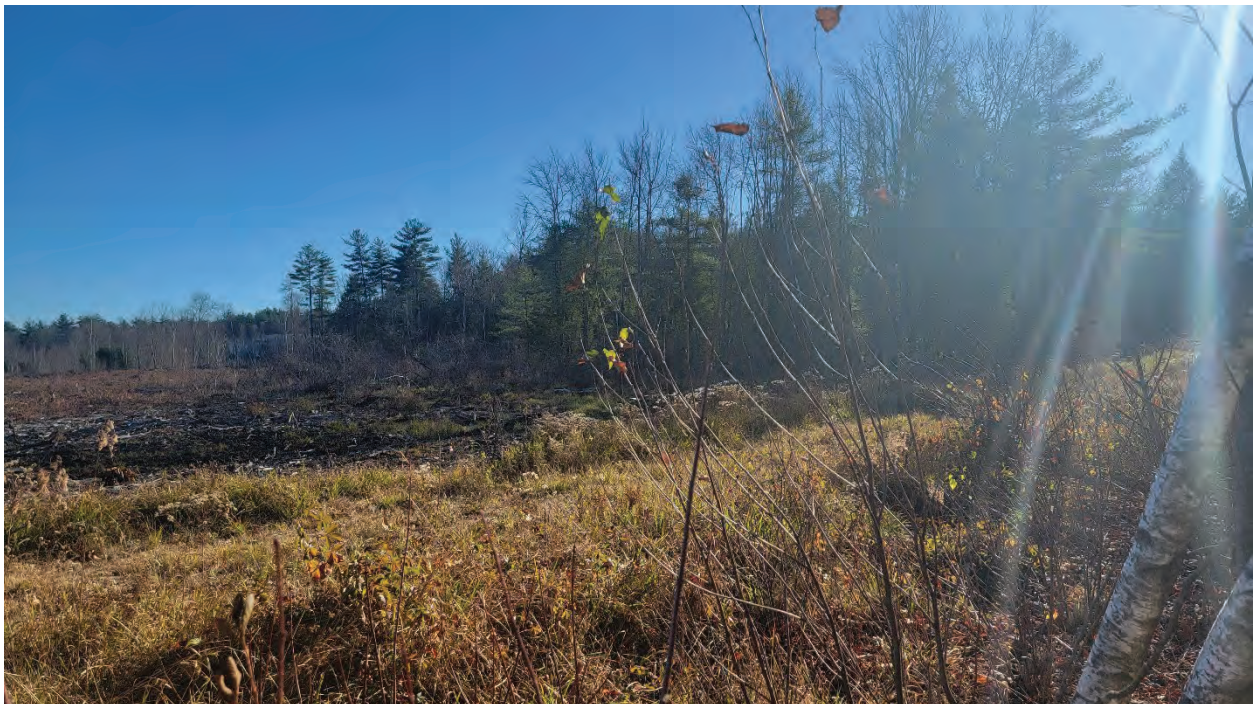
Photo 15 – Wetland Restoration Area #2 – View west across proposed Restoration Area #2 in Wetland C (photo taken 11/10/22).

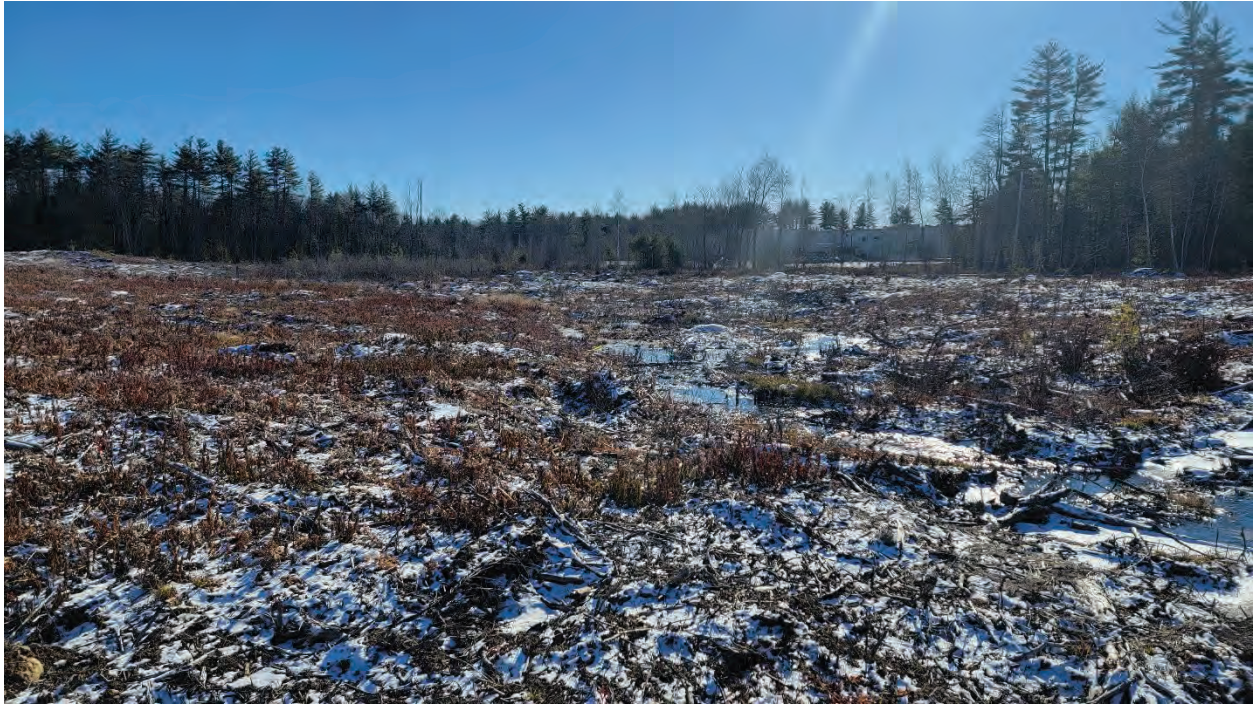
Photo 16 – Wetland Restoration Area #2 – View east across at Restoration Area # 2 in the (photo taken 12/13/22).

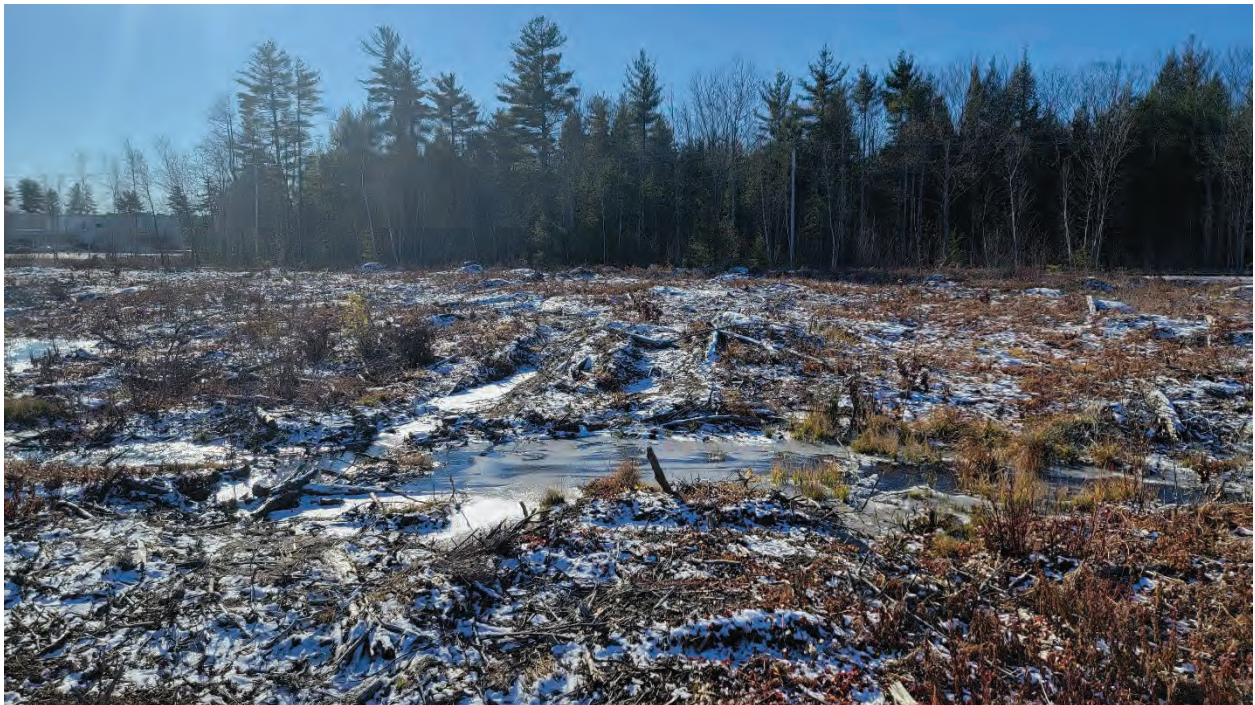
Photo17 – Wetland Restoration Area #2 – View south along proposed Wetland Restoration Area #2 Wetland C (photo taken 12/13/22).

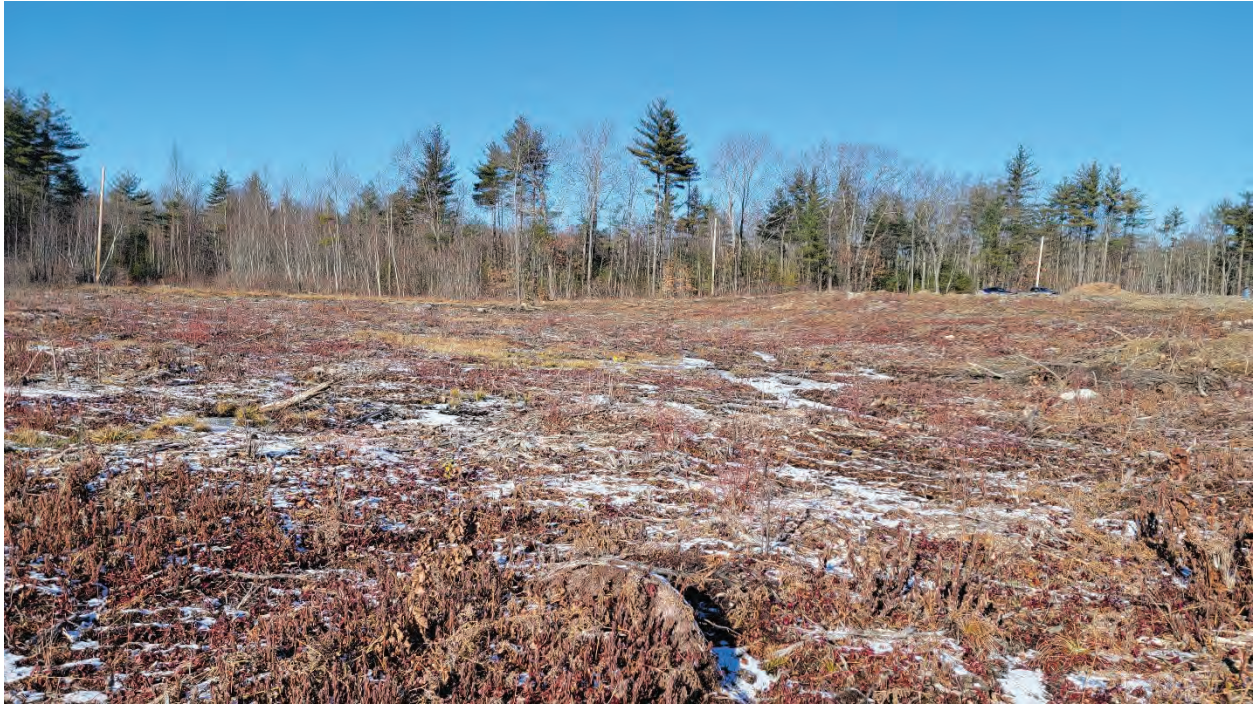
Photo18 – Wetland Restoration Area #2 – View north along proposed Wetland Restoration Area #2 (photo taken 12/13/22).

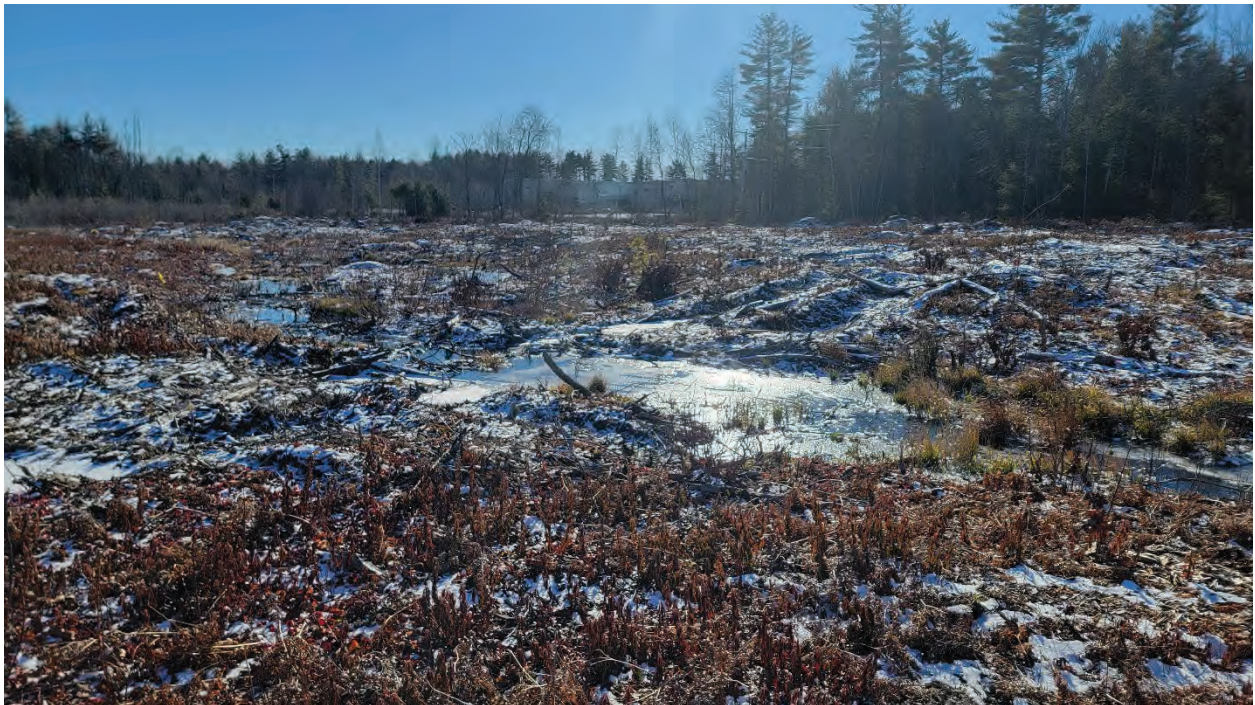
Photo19 – Wetland Restoration Area #2 – View along Wetland Restoration Area #2 in Wetland C along forestry activities (photo taken 12/13/22).

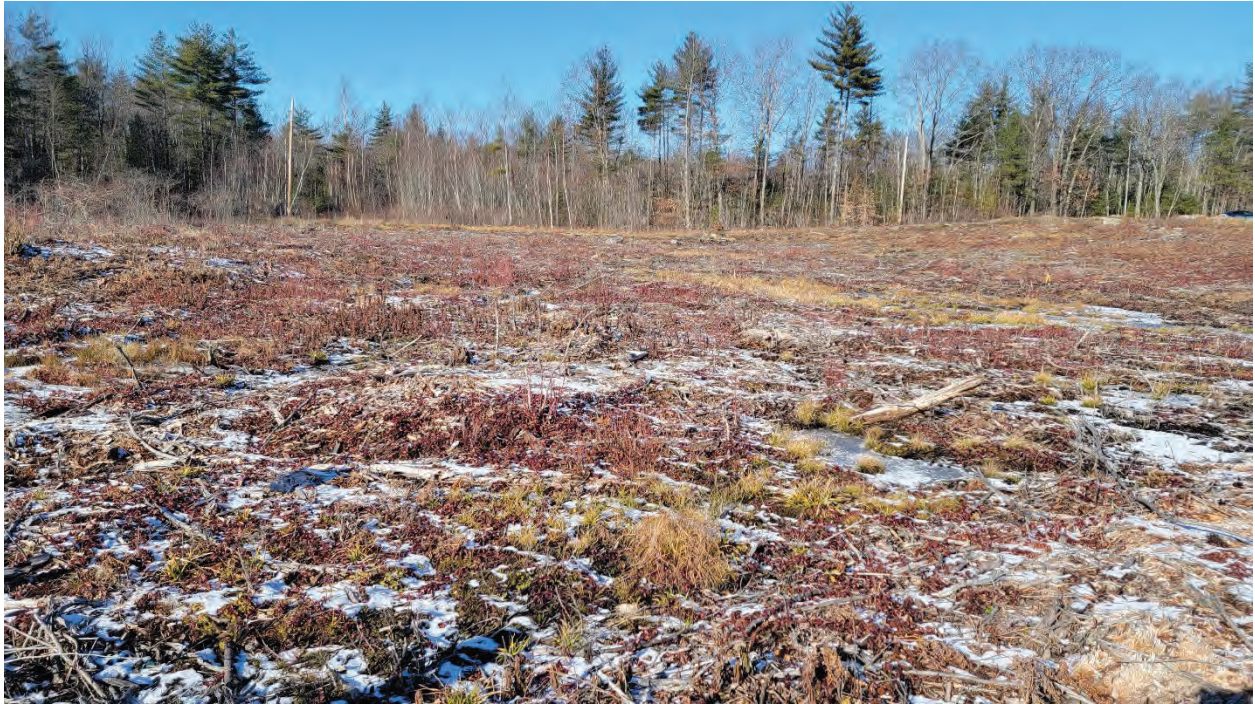
Photo 20 – Wetland Restoration Area #2 – View within Wetland Restoration Area #2 in Wetland C (photo taken 12/13/22).

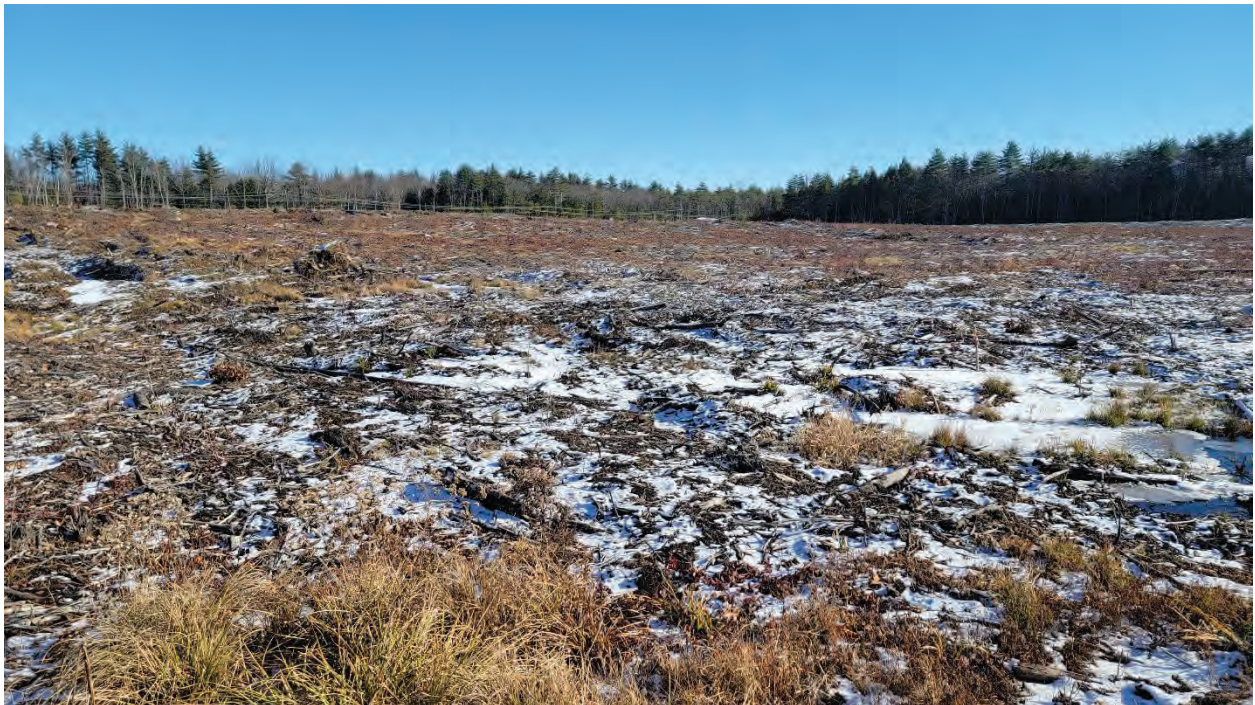
Photo 21 – Wetland Restoration Area #2 – View within Wetland Restoration Area #2 in Wetland C along impacts by forestry activities (photo taken 12/13/22).
