Road Safety Audit Rochester, NH

Intersection: Old Dover Road and Tebbetts Road

Presented by
VHB

September 12, 2019

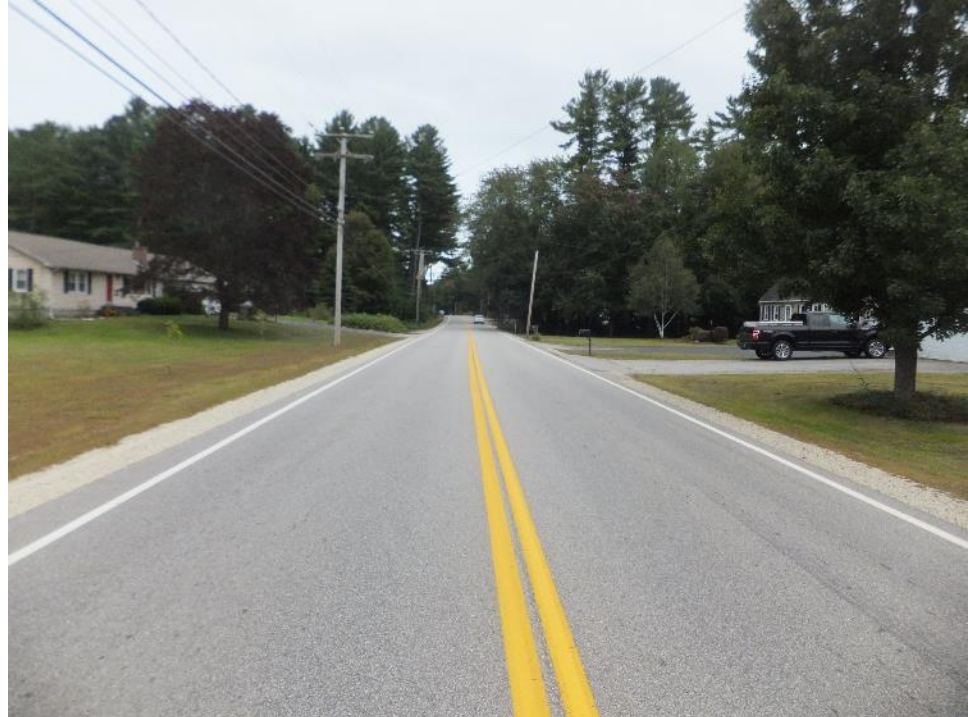
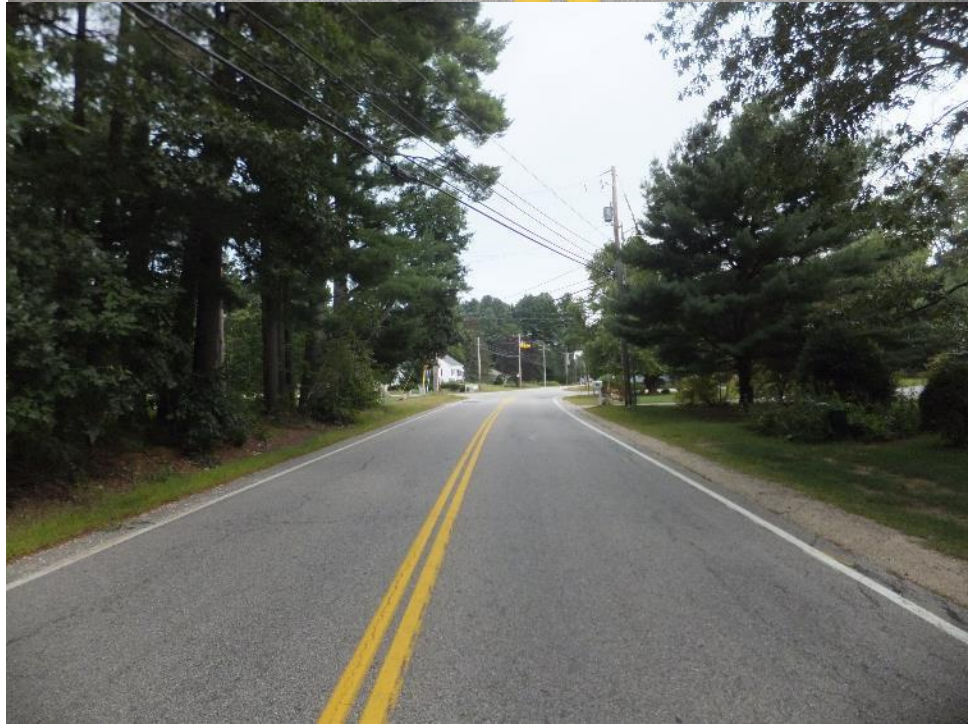
- Old Dover Road
 - 2-lane road
 - 35 MPH (Posted)
 - No turn lanes
 - Flashing yellow signal

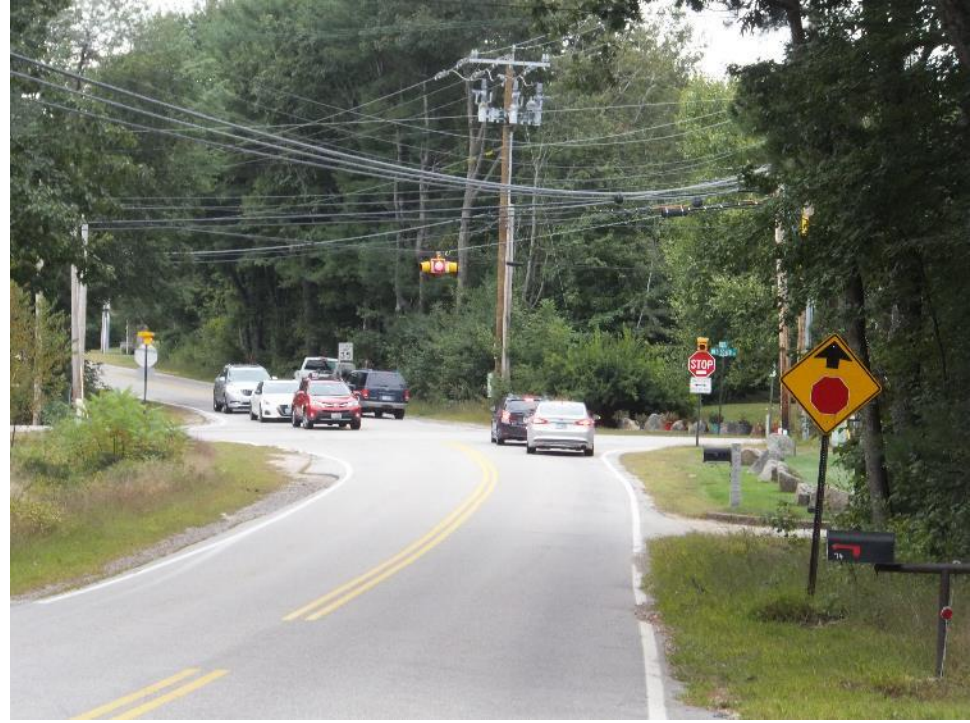
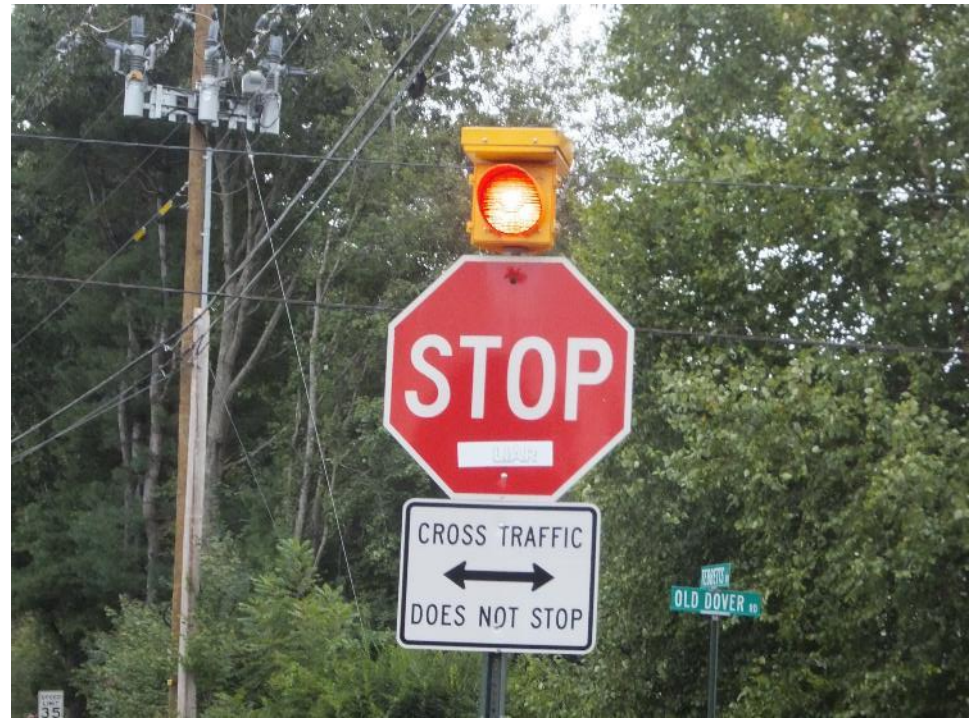
- Tebbetts Road
 - 2-lane road
 - 30 MPH (Posted)
 - No turn lanes
 - Stop-controlled
 - Flashing red signal

- Good placement of stop bars but refresh eastbound stop bar
- Realign flashing beacon on STOP sign on eastbound approach
 - Look into flashing pattern and change as needed
- Replace 'Cross traffic does not stop' signs with yellow signs to help with conspicuity of the intersection
 - Look into research for placement of supplemental plaque under STOP sign (abutting or space in between)

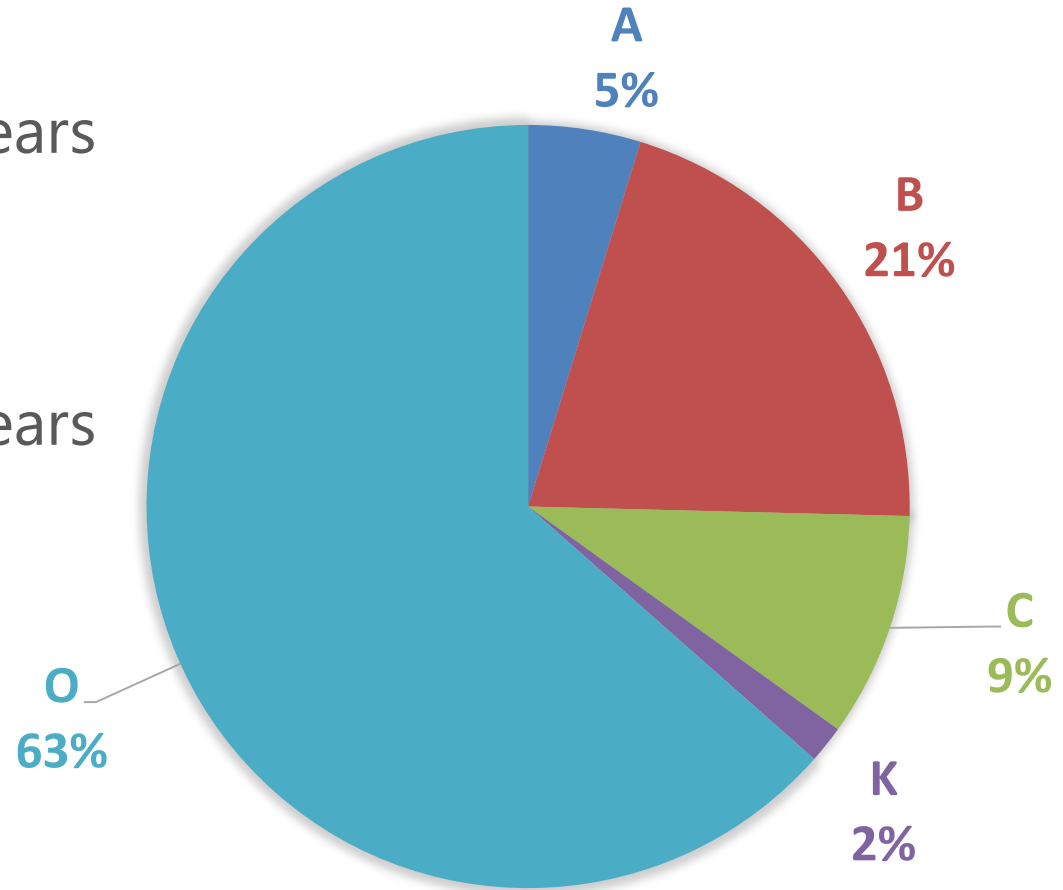
- Total crashes
 - 63 crashes in 12 years
 - 5.3 crashes/year
- Injury crashes
 - 23 crashes in 12 years
 - 32% of crashes
- 3 A-injury crash
- 1 fatal crash
