REPORT

CITY OF
Rochester
New Hampshire

Year One I/I Investigations – Phase 2 –
CCTV Inspections

Re: **Year 1 Phase 2 I/I Investigations CCTV Video Review**

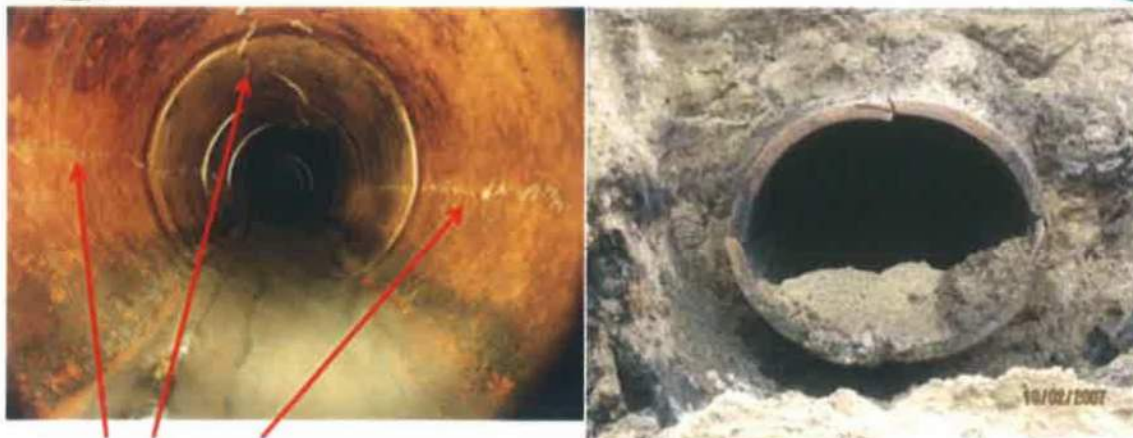
Hinge Defects

<p>Stage 3 - The <i>loss of support from the surrounding soil allows the crown to drop</i>. This deformation leads to pipe collapse, which occurs due to the weakened wall.</p>

Examples of pipe deterioration likely created during construction

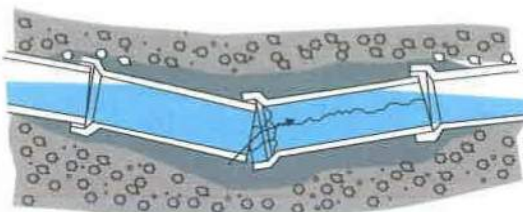
<p>Stage 3 - Uneven loading of pipes due to joint displacement and lack of support from the surrounding soil causes pipes to crack or fracture. As the process accelerates, cracked or fractured pipes may also break and deform. Some visible defects are: <i>open and displaced joints, cracked and fractured pipes, loss of line and sag</i>. The camera may be submerged due to water level increase caused by the reverse grade.</p>
