# REPORT

CITY OF  
**Rochester**  
New Hampshire

Year One I/I Investigations – Phase 2 –  
Sewer Manhole Inspections

Re: **Year 1 Phase 2 I/I Investigations: Sewer Manhole Inspections**

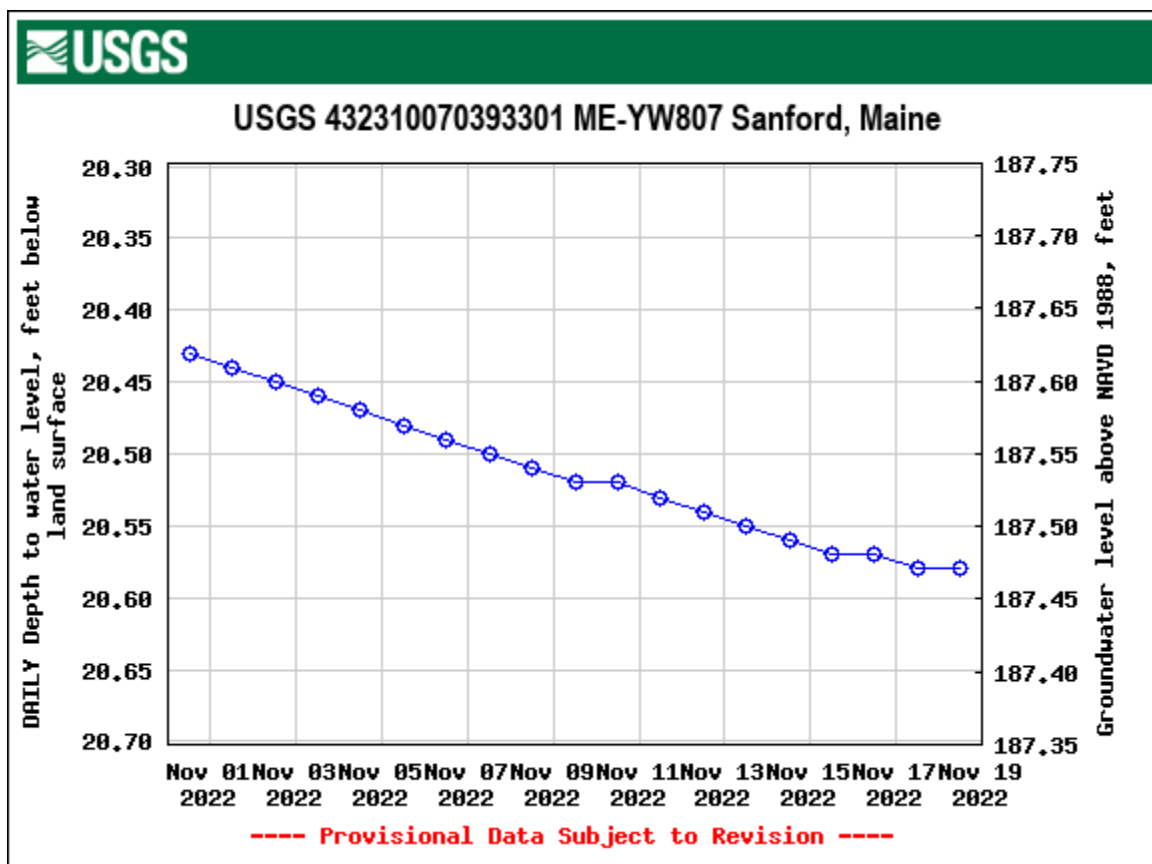
Figure 1: USGS Groundwater Gauge - Sanford, ME

A permanent United States Geological Survey (USGS) groundwater gauge located in Sanford, Maine monitors groundwater levels. Data from this groundwater gauge serves to indicate the general groundwater trends of the region. It should be noted that this USGS gauge is located approximately 20.6 miles away from the Rochester border and is not necessarily an accurate representation of the groundwater levels in Rochester. However, the Sanford groundwater gauge does provide an indication of groundwater trends in the area. A graph representing the groundwater readings recorded during the study period from the USGS gauge is shown in Figure 1 below.
