HISTORIC PRESERVATION PROGRAM - STRAFFORD ROCKINGHAM REGIONAL COUNCIL  
One Water Street, Exeter, New Hampshire 03833 Phone; (603)778-0885

SURVEY NUMBER: 64

COMMON NAME: Palmer Supply Company

HISTORIC NAME: Wallace Shoe Company  
Set back 100 yds. behind the

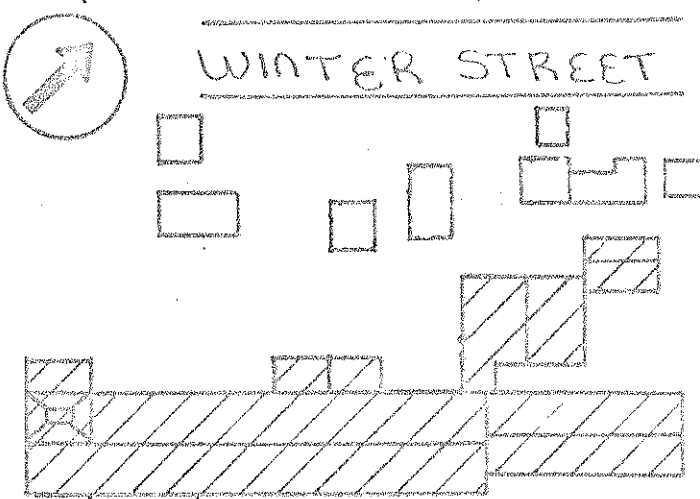
PHOTO

Description of View: Three Quarter South  
East  
Negative File Number: R-80-A5-20  
Photographer: Roger Brevoort  
Negative on file with: SRRC

The Palmer Supply Company building is a wood-frame factory dating C. 1890. The 3 story structure has a low-pitched gable roof and is 6 bays wide by 8 bays long, giving it a narrow, rectangular form. Most of the windows retain their original 6/6 sash. The exterior is sheathed with asphalt shingles.

The most distinguished feature is an offset stair tower located on the northwest corner, topped by a truncated pyramidal roof. Architecturally the tower correlates the building with the other late nineteenth century structures in the Wallace Shoe complex.

At the east end of the Palmer building, a cinder block addition connects to a small clapboard structure, presumably a power house, which relates to a tall, 4' square smoke stack featuring a corbelled cap. Several other small additions, including a two-story gabled wing are appended to the north elevation.
