HISTORIC PRESERVATION ASSISTANCE PROJECT

| COMMON NAME: The V.F.W. Hall | | FUNCTIONAL TYPE: Hall |
| LOCATION: 55-57 Hanson Street | | ARCHITECT/BUILDER: Unknown |
| STYLE: Colonial Revival/Bungalowoid | | |

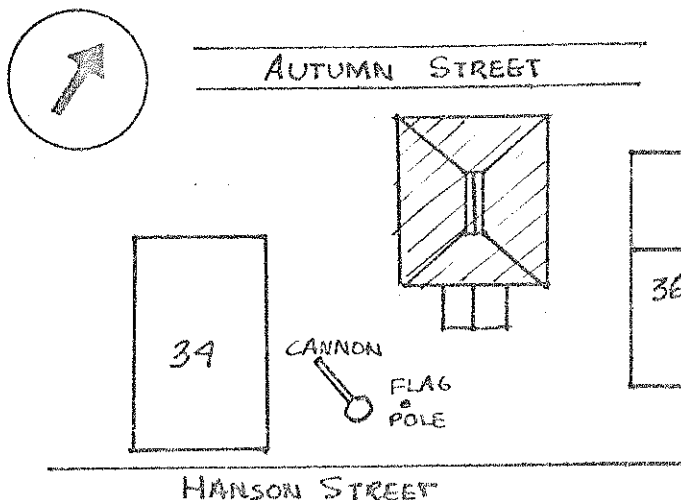
PHOTO

Description of View: Three Quarter
Northeast

The VFW hall, rebuilt from an earlier brick structure is an interesting blend of Colonial Revival motifs and a suggestion of the Bungalow design, both styles being common through the early portion of the twentieth century. The essence of the Bungalow style derives from the relatively square, flat proportions that give it a horizontal appearance, and the sharp roof overhang.

Its Colonial Revival motifs include the hip roof, the gabled entry portico and the side-lights flanking the paired doors of the entry. The three part window in the center bay of the second story, the stone lintels of the first story windows, and the 6/1 window sash throughout are all Colonial Revival elements.
