**HISTORIC PRESERVATION PROGRAM - STRAFFORD ROCKINGHAM REGIONAL COUNCIL**  
One Water Street, Exeter, New Hampshire 03833 Phone: (603)778-0885

| COMMON NAME: Carney Drugs | | FUNCTIONAL TYPE: Commercial |
| LOCATION: 32 North Main Street | | ARCHITECT/BUILDER: Unknown |

| COMMON NAME: The Keef Building | | FUNCTIONAL TYPE: Commercial |

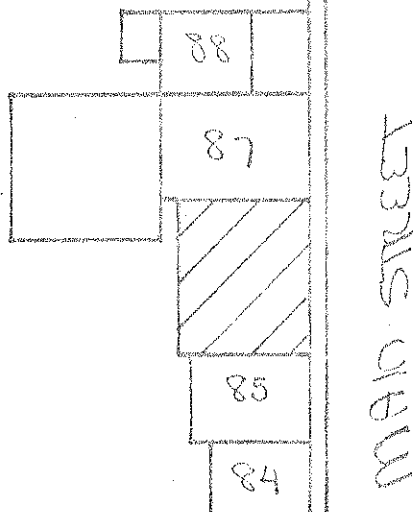
**PHOTO**

Description of View: Facade, looking west

Carney Drugs occupies a one story 1920's commercial structure. Metal framed display windows and a sign architrave characterize the facade, which is an extensive alteration of the original. The age of the building is today illustrated only by the rear walls, which are brick, with irregularly spaced windows beneath segmental arches.

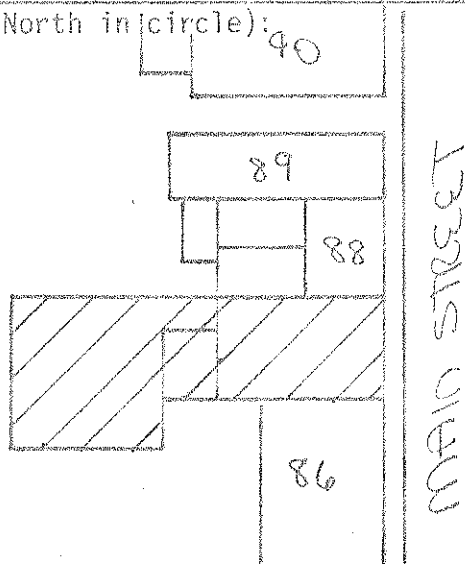
PHOTO

Description of View: Facade West

With simple detailing, this is an early twentieth century commercial building characterized mainly by three rectangular windows across the second story each with a transom. The openings are topped by a brick flat arch and have stone sills below. A band of block brickwork, a pressed metal architrave and a slightly projecting cornice articulate the roofline.

The storefronts level has been altered.
